Aga Khan Planning and Building Services, Pakistan  
Building and Construction Improvement Programme – BACIP

# **FIELD VISIT HABITAT RISK MANAGEMENT PROGRAMME (HRMP)**

**NOVEMBER 2008**

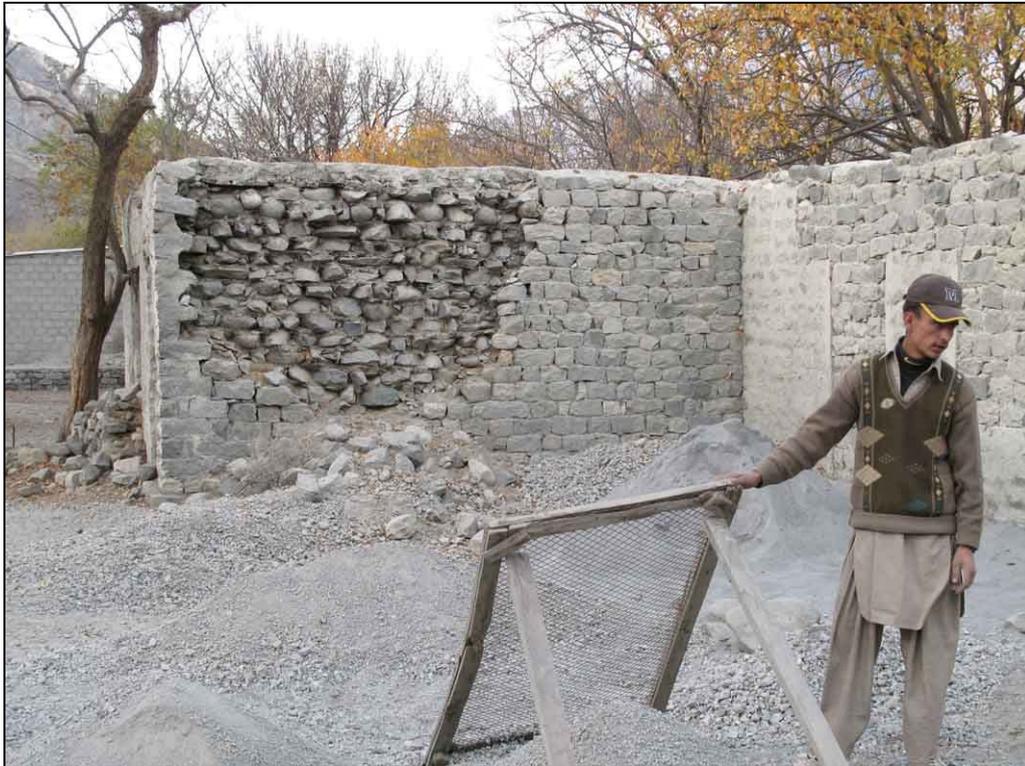
Non-cement masoned traditional houses and some public schools constructed with cut-face stones fall apart by themselves due to numerous small earthquakes and erosion. Seismically retrofitting these walls with external reinforcement (columns, tie beams or stitches) is a useless exercise; reconstructing is the only recommended option.

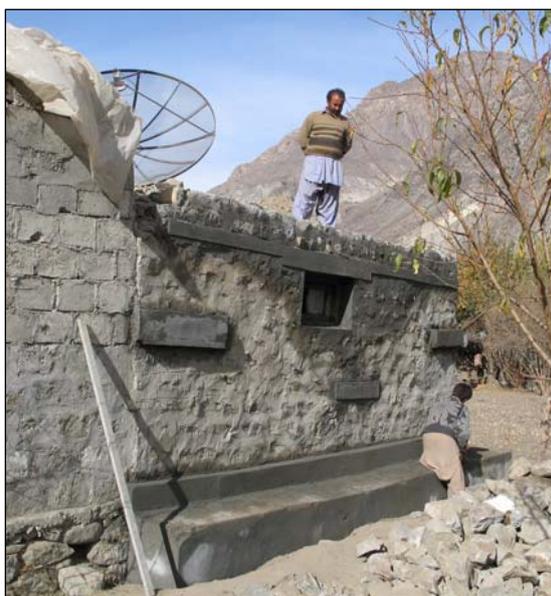
**Left:** Outside wall of the main room with foundation ring beam and wall stitches.

The main living/guest room, once retrofitted with the new reinforced concrete wall plate ring beam construction and lighter roof construction, will better withstand earthquakes. However, while the heavy inside and outside plinth reinforcement (and waterproofing) may prevent the wall from cracking due to vertical settlement of the building (wet underground), new cracks can easily develop right next to the newly made stitches because of the loose internal stone masonry of the walls.

The stitching looks impressive, but it is more a psychological improvement as it contributes little to the overall strength of the room. In the event of an earthquake, it will be the upper wall plate ring

beam keeping the walls together, not the stitches. It needs to be assessed if it is worth the money, especially as the building is a ground-floor-only construction.

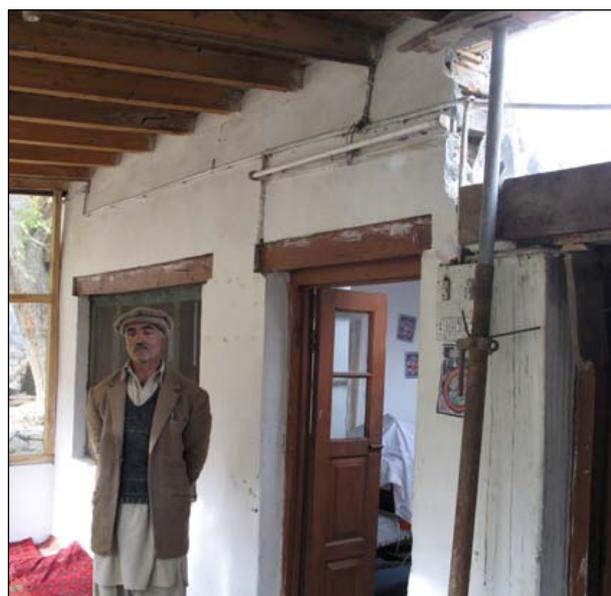
**Right:** House owner in front of bedroom – the lintels are not linked nor connected to the main room wall plate ring beam (right of bedroom door).

Neither the lintels over the door and window of the bedroom (see photo page 2, right), nor the lintels of the kitchen, were connected to the ring beam of the main room. This was based on the idea that the programme would only improve the main living/guest room. The mission was of the opinion that it would have made more sense to avoid disturbing the massive old columns and instead connect the interrupted lintels to the ring beam (for less cost). Only the living room (or the visitor's part of the house) was dealt with, while the occupants obviously would spend most of their time in the bedroom (12 hrs/day), the kitchen (6 hrs/day) and outside.

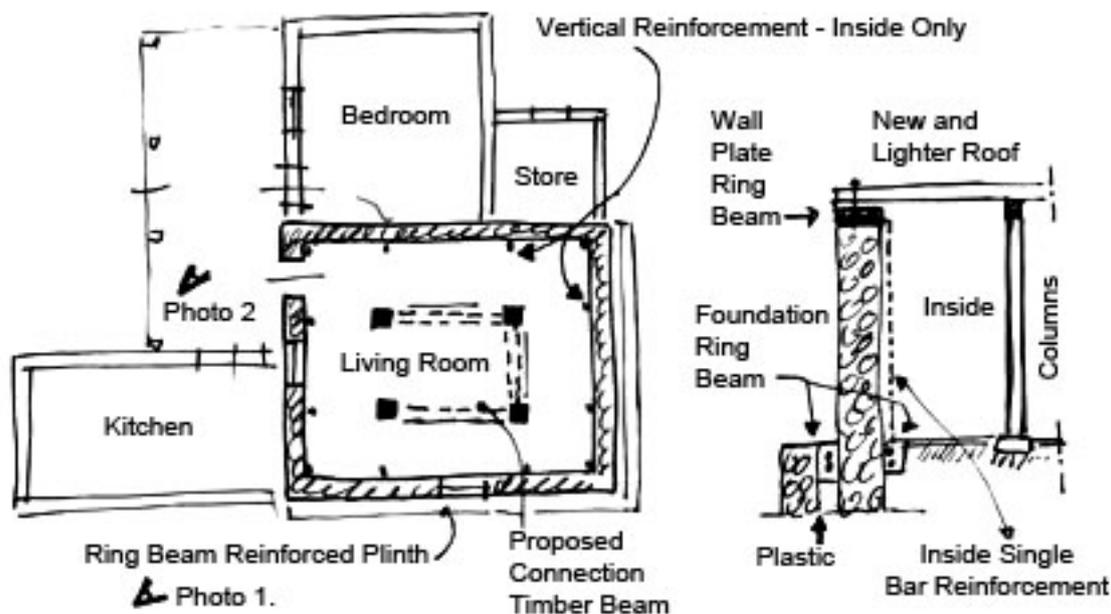
**Left:** Floor plan of the house consisting of the central (traditional) living room with adjoining kitchen and bedroom. During the winter period, the living room is seldom used (only for visitors).

The position of the photos (page 2) is indicated in the sketch.

**Right:** House section showing the lower foundation ring beam reinforcement and waterproofing.

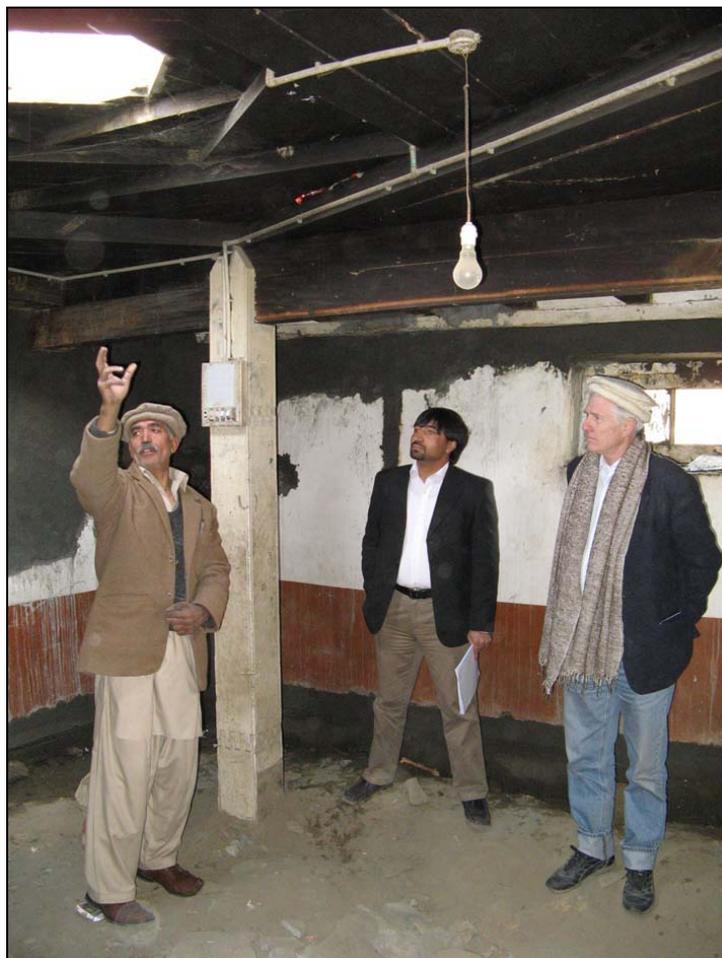
Traditional Pamiri houses have low vulnerability for earthquakes, but when retrofitting, the roof should be made lighter and thermal insulation applied, including a roof hatch window.

- Retrofitting traditional houses having strong wooden support columns should consist of lightening, insulating and waterproofing the roof construction; and reconstructing the walls using less material, but with internal wall reinforcement and cement mortar, and applying thermal insulation.
- Retrofitting should include the **entire house** and not only one room. In addition, a seismically retrofitted room should be adequately strong enough to allow the possibility for a future lightweight upper storey. The design of lightweight constructions would be a challenge for BACIP.
- Local stitching of cracked walls consisting of masoned stone and rubble does not add much to the strength of the wall as a whole, making it a costly exercise that should not be repeated. It is better to frame the entire wall sections as shear walls.

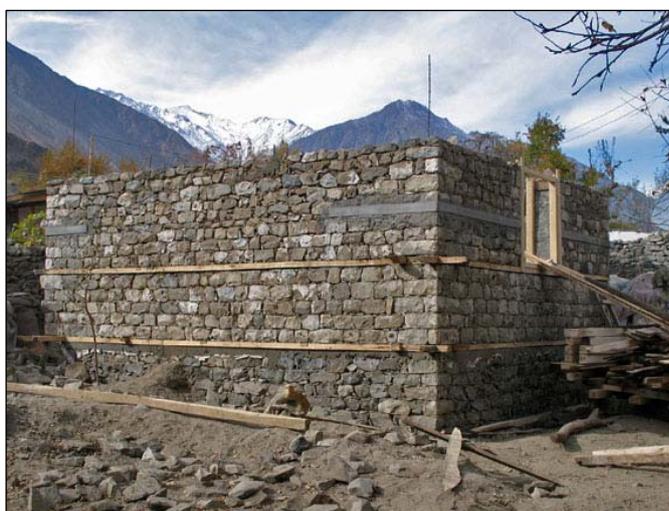
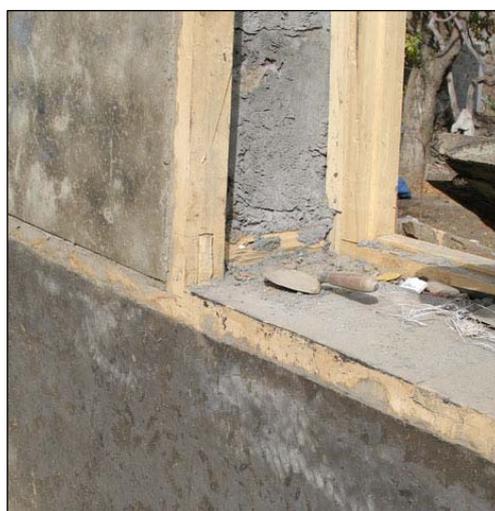
A few vertical reinforcement bars have been placed inside the wall corners and horizontal wooden beams (from the demolished house) were used as tie beams in a 16" masoned stone wall. In the upper part of the wall, a horizontal steel bar reinforcement was used around the corners (picture below, left), but no BACIP-GWR was used in the wall construction. It is unclear why this concrete upper corner and wall reinforcement is not continued throughout the wall, as the additional cost would be minimal. The created continuity in the reinforcement would substantially strengthen the long wall against lateral earthquake forces. The inside wall was plastered with a straw plaster mix with volumes of: 1 cement / 2.5 chopped straw / 10 clay soil, providing a one-inch thick insulating plaster (see photo below, right); a similar plaster was used on the floor.

**Left:** House 2 – the floor is at the level of the first timber line; entrance door is at the rear.  
**Right:** Insulating plaster layer at the window opening.

- Timber should not be used for structural wall reinforcement in new houses, especially not when it is supposed to serve as a demonstration house. There is very little binding between timber and stone construction, insufficient timber cross ties are generally applied, the overlapping connections in the corners are weak due to their short length, and the cost of the timber is prohibitively high for people who do not have access to a free timber supply.
- Reconstruction of dilapidated traditional houses is a better option than retrofitting. It is important, however, to take the physical needs of the house owner into consideration in reconstruction, especially if one is physically handicapped or cannot walk.

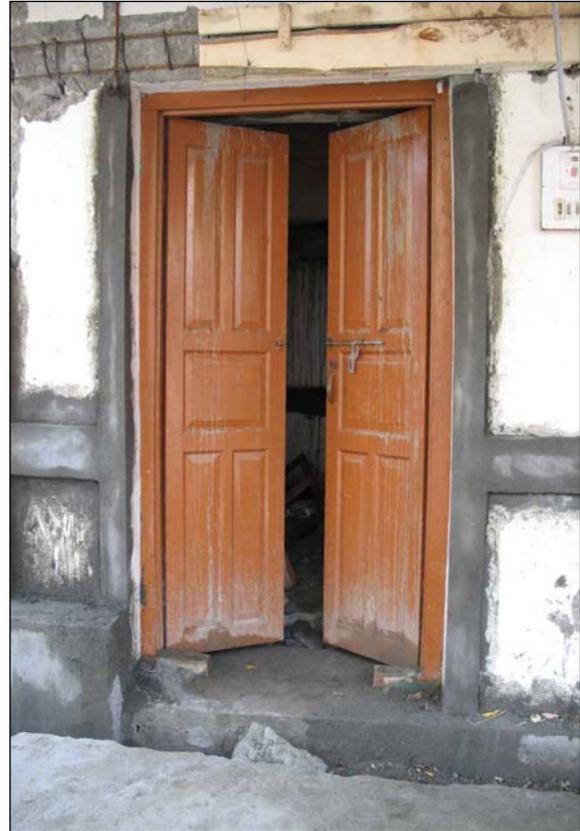
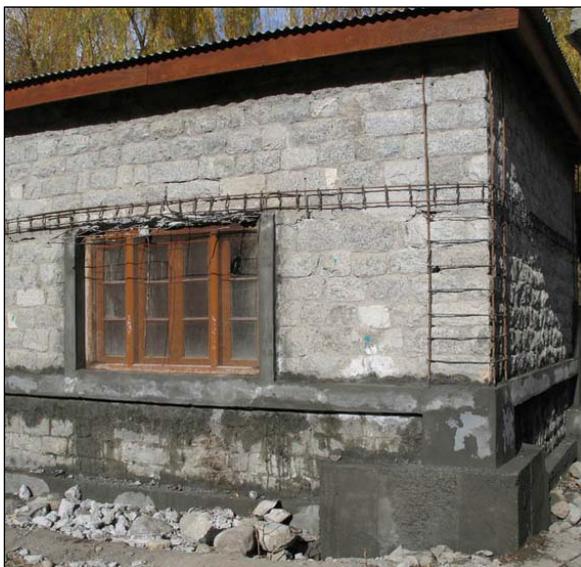
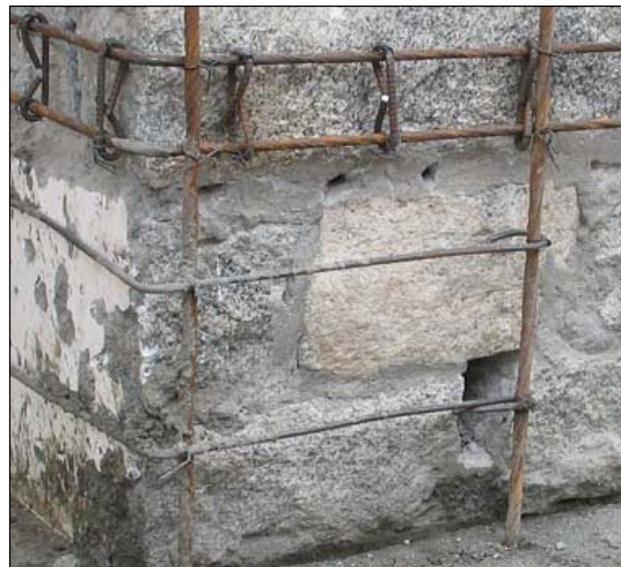
The classroom doors still opening to the inside, obstructing a free escape route in the event of an earthquake.

As could be observed from the reinforcement details of one of the exterior columns, the lintel strip reinforcement is going inside the vertical reinforcement while these should be fitted around the vertical reinforcements.

In addition, in the opinion of the mission, the number of through-the-wall anchoring is insufficient and the single bar with hook inadequate.

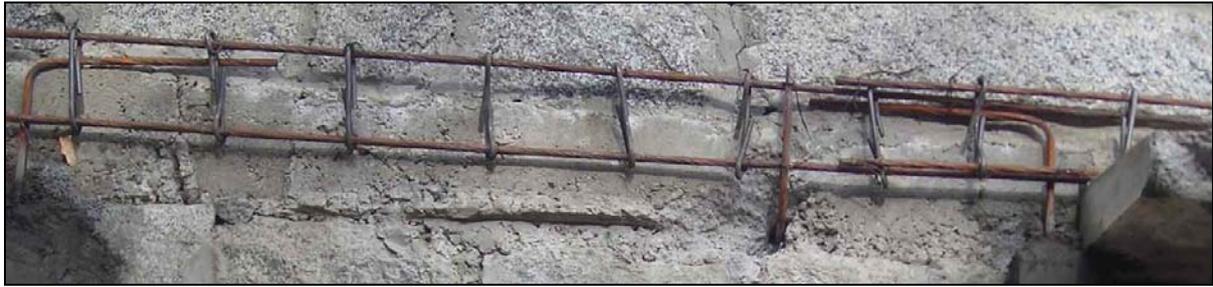
The connection between the inside ring beam and outside ring beam is based on only one single bar passing through the wall instead of going back again, making a full loop. The number of through connections between the inner and outer ring beam is rather low. The vertical bars are from the window framing, placed correctly<sup>3</sup>.

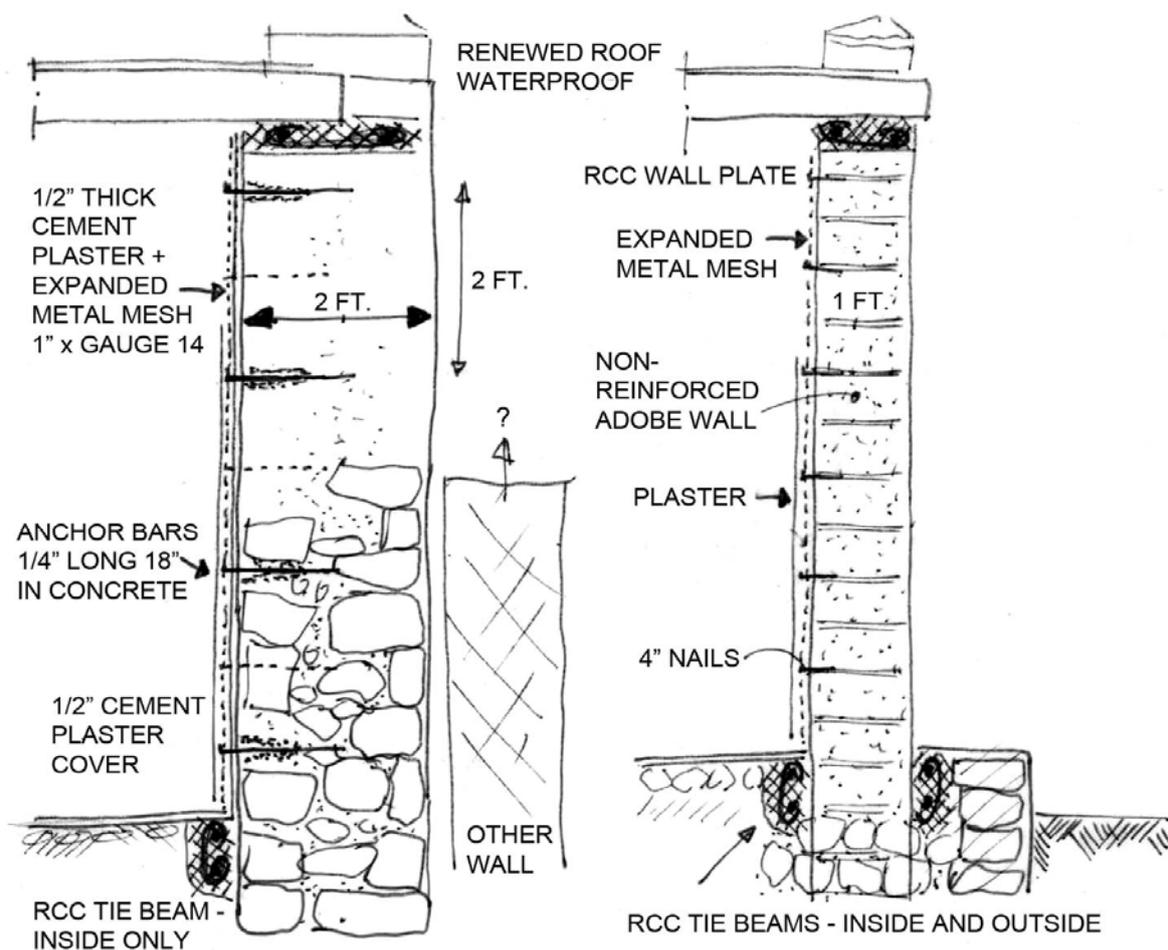
**Left:** This sketch illustrates the technique used to anchor the 2-ft. heavy stone and rubble wall of House 4 where a 1" expanded metal mesh and plaster is placed on one side only. The cemented anchors will only grab onto some of the outer face stones. Because the rubble stone masonry walls are internally loose, it does nothing for the other face.

**Right:** Sketch of House 5. The anchoring in the adobe wall is even worse. Those anchors hold onto nearly nothing in the adobe or clay bricks.

- Such a construction is not only costly, but strengthening only one face of a weak stone wall does not really add to the strength of the wall to withstand earthquakes, especially not when it is a supporting wall. In the case of a 2-ft. thick rubble stone masonry wall, the **best thing is to totally reconstruct the 20-ton wall** and reconstruct it in a lighter way. The two sketches of House 4 and House 5 (below) are the technical details according to the architect.

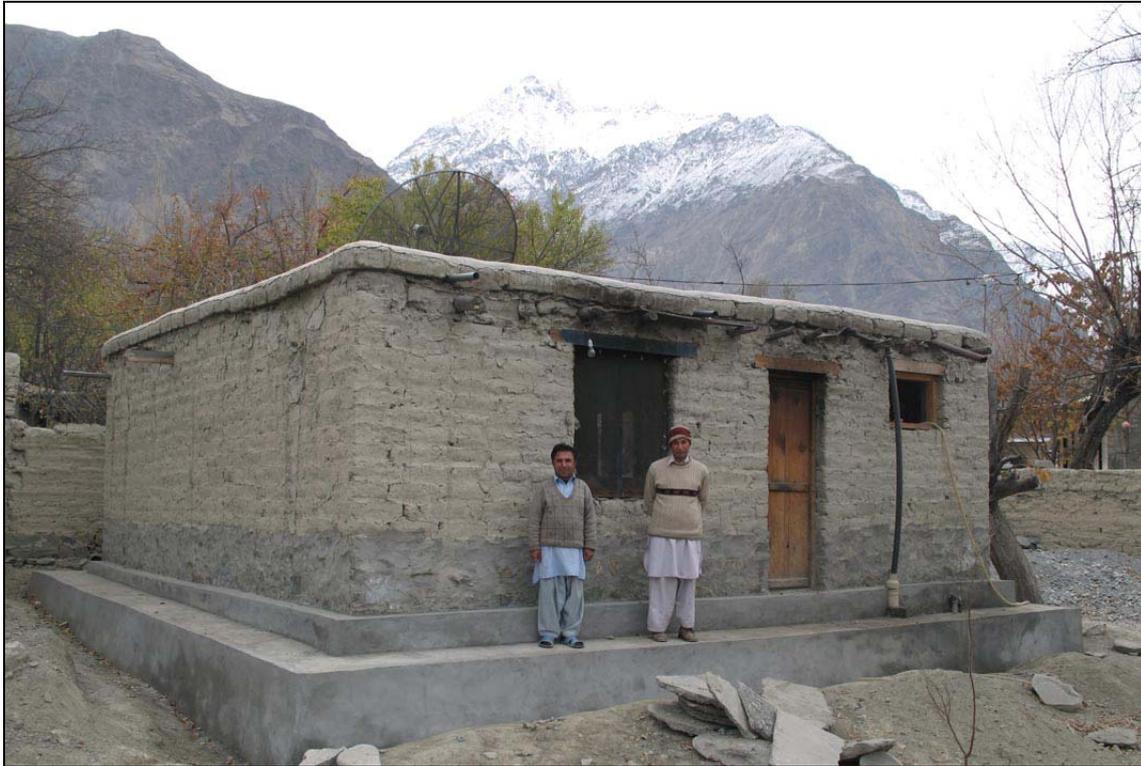
View of the massive foundation ring beam of the small one-floor-only adobe house

The proposal for strengthening the inside wall of the house was even more surprising than House 4 because the expanded metal mesh was supposed to be “nailed” into the adobe (see sketch page 9, right). To the opinion of the mission, the money would have been better spent on a thermal wall construction because the current “wall reinforcement” will fold like a sheet of cardboard when the adobe wall fails during an earthquake.

Adobe walls should be entirely reconstructed with the GWR instead of applying external “reinforcement”.

- Based on the excessive work and cost of the foundation ring beam for a ground-floor-only adobe house, as well as the nonsense internal wall reinforcement, **the mission advises to review the technicalities of this kind of retrofitting.**

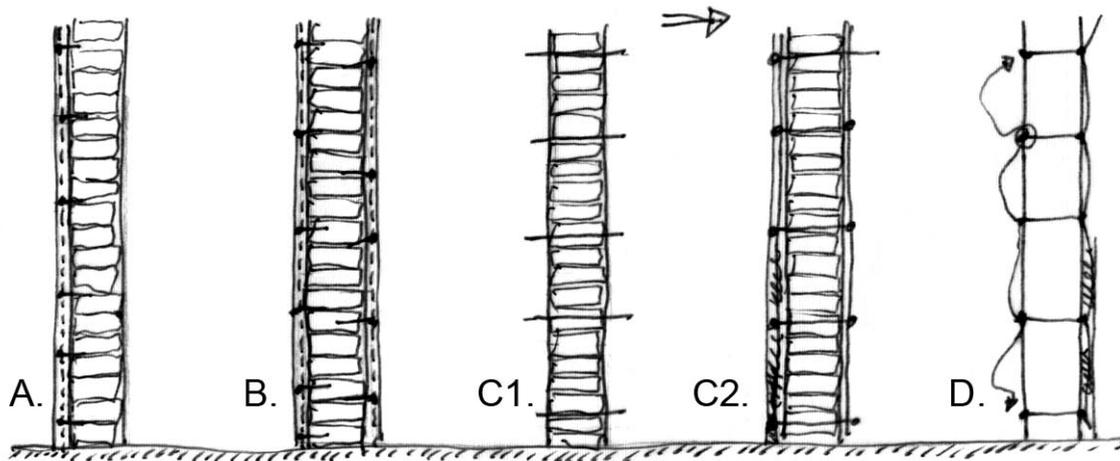
**Sketch A** refers to the adobe House 5, one-sided “anchoring”. This will easily be pulled out of the clay adobe blocks if the wall bulges to the right.

**Sketch B** is an “anchoring” on both sides. This will strengthen the wall slightly as a shear wall, but with alternating lateral forces, the anchored plasterwork will immediately peel off from the inside where the wall bulges outside, and vice versa.

**Sketches C1 and C2** indicate an improved solution: many 2 mm GI wires are poked through the wall; on each face an expanded metal mesh is fixed to the protruding ends of the wires and the expanded metal mesh plastered. This will reinforce the wall both laterally and as a shear wall.

**Sketch D** is the option where the wall is newly masoned with horizontal BACIP-GWR, being ½" to 1" wider than the adobe wall. A series of vertical 2 mm GI wire is connected to all horizontal GWRs. This way a GI wire network is created on each face of the adobe wall. Both sides are plastered, causing an intimate contact between the GWR side reinforcement and the wall. This reinforcement provides lateral and shear reinforcement.

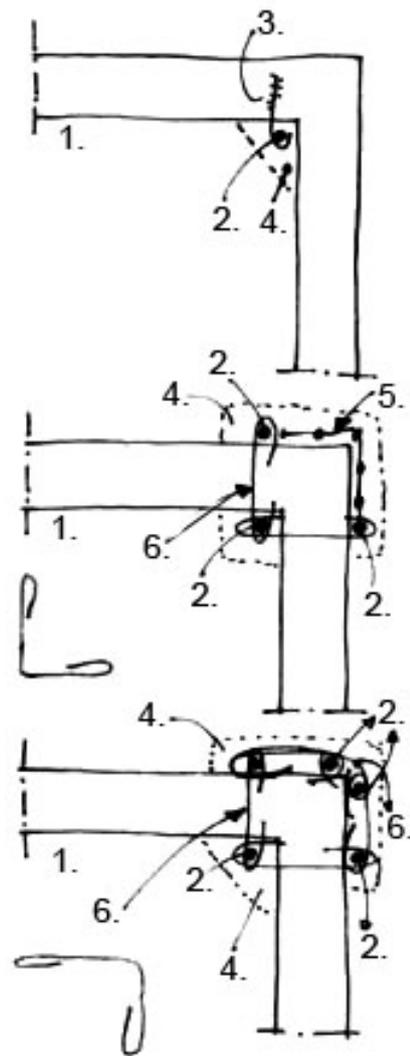
The top sketch shows the position of the vertical reinforcement in Houses 1, 4 and 5.

The single bar (2) is supposedly anchored between the foundation ring beam and wall plate ring beam, and possibly nailed (3) to the wall (1).

The inside corner bar is then plastered (4).

This solution does not provide sufficient anchorage of the bar, with the effect that the bar will pop loose from the wall during an earthquake.

The second sketch shows a suitable minimum design.

The inside bar (2) is linked to the outside bars (2) in two directions (6). L-shaped bars can be used.

The two vertical outside bars are linked around the corner with a strong wire mesh (5), and the reinforcements are covered with strong cement mortar plaster (4).

The third sketch shows the solution as planned for the school retrofitting with double inside and outside vertical bars.

Compared with sketch two, additional bars are placed in the outside corner (2) and all linked to each other (6). L-shaped stirrups can be used.

The reinforcements are covered with strong cement mortar plaster, indicated by the dotted lines (4).

For vertical wall reinforcement, columns need to be formed by linking the inside and outside bars.
