Dhamar Aided Self Help  
Reconstruction Project

SUBJ: VISUAL REGISTRATION OF THE BUILDING OF THE STAFF HOUSES  
PLANNING ACTIVITY NO 50.

Diskette: 650.NYN.ORG  
DHAMAR AIDED SELF HELP RECONSTRUCTION PROJECT  
FILE: 3.4160.62.03  
DATE: 29 JULY 1984  
SUBJ: VISUAL REGISTRATION OF THE BUILDING OF THE STAFF HOUSES  
PLANNING ACTIVITY NO 50. (addition to house construction 1)

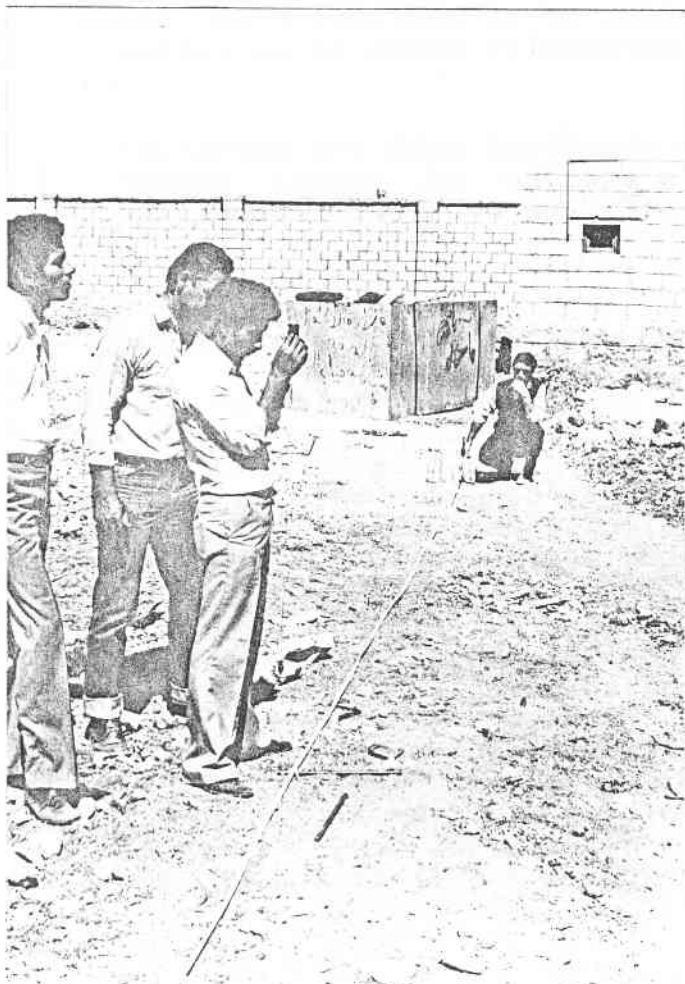
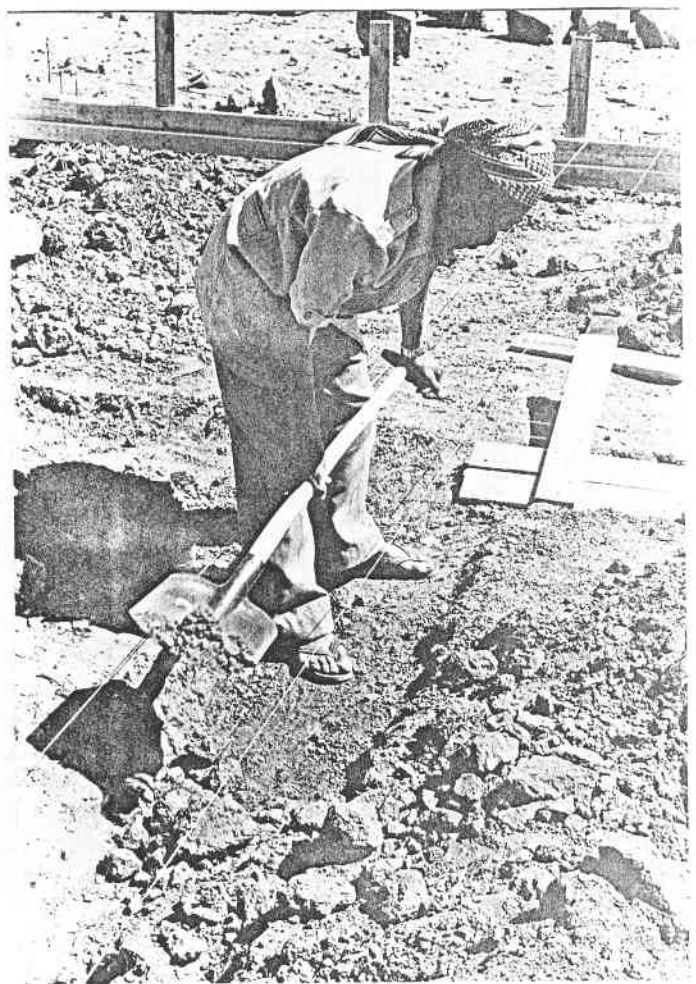
Over the total construction area a grid system was laid, along which the different houses were coordinated. This grid was established with a double pentagon prism and a measuring tape.

The position of the foundations was indicated by means of steel rods and masonry lines. The excavation was done between those lines.

Since construction was realized nearly directly on the hard rock, very little excavation was necessary.

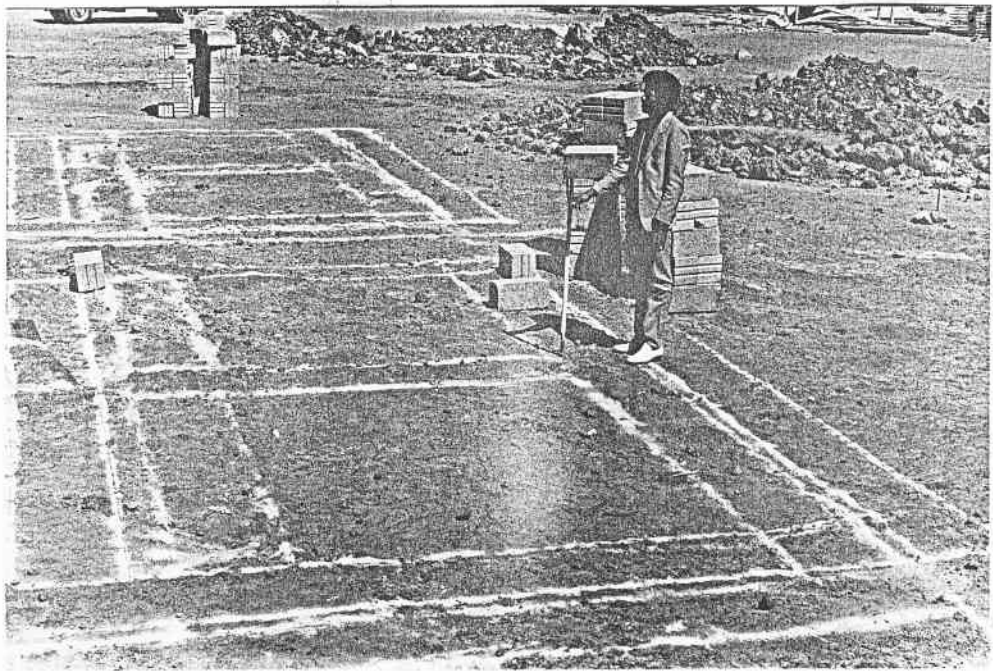
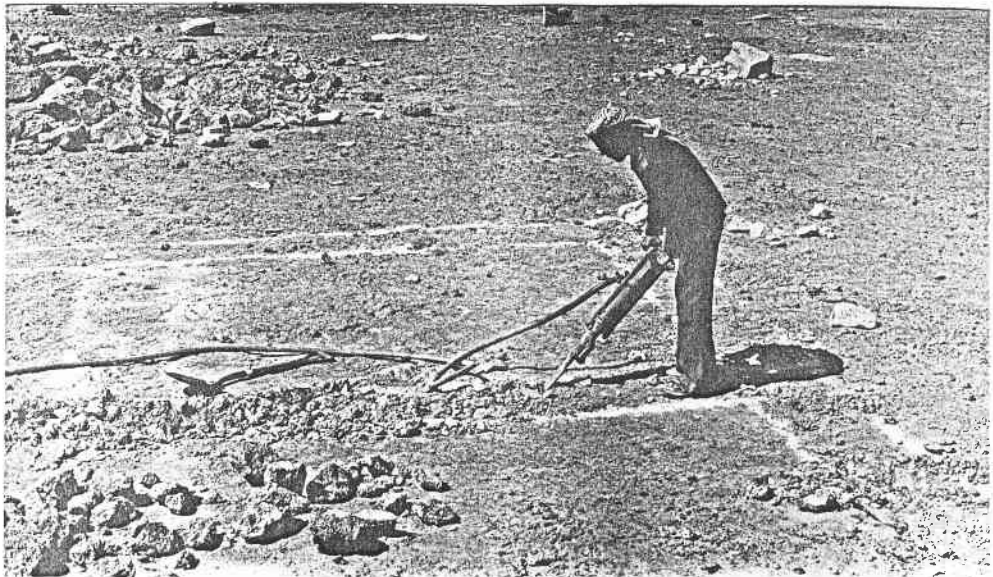
A better way of tracing the foundation was found by using chalk, which was dropped by hand along the masons line. This way the masons line could be removed and easy excavation work was possible.

The contractor working simultaneously on the same terrain used a pneumatical hammer in order to loosen the surface soil. It is considered that if the soil is so firm that pneumatic gear has to be used in order to loosen it, it does not have to be loosened at all.

On the other hand it is important that running surface water after heavy rains, cannot undermine the foundation. In that case, with superficial foundations, direct contact has to be found with the rock.

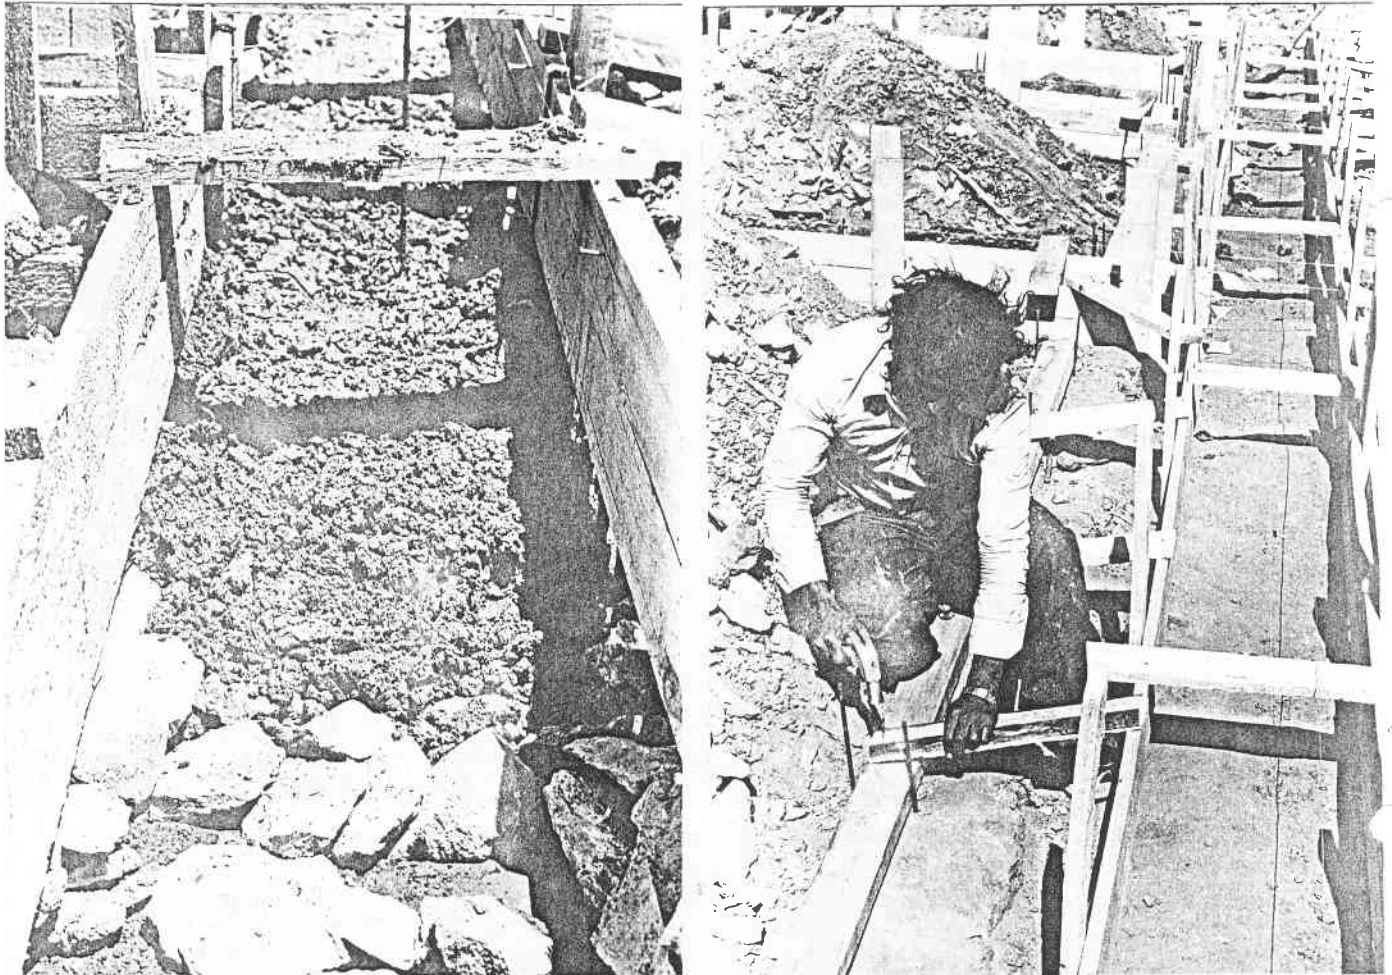
For the casting of the foundation strip a timber formwork was used, consisting of two planks and vertical cross timbers. The verticals were kept rather long, so it would be possible to use the timber afterwards for other purposes. On top of an unreinforced concrete layer including stones, a reinforced layer was cast. The same type of timber formwork was used for this second layer, using smooth timber. The amount of timber used proved to be inconvenient because of the high pieces sticking out and expensive.

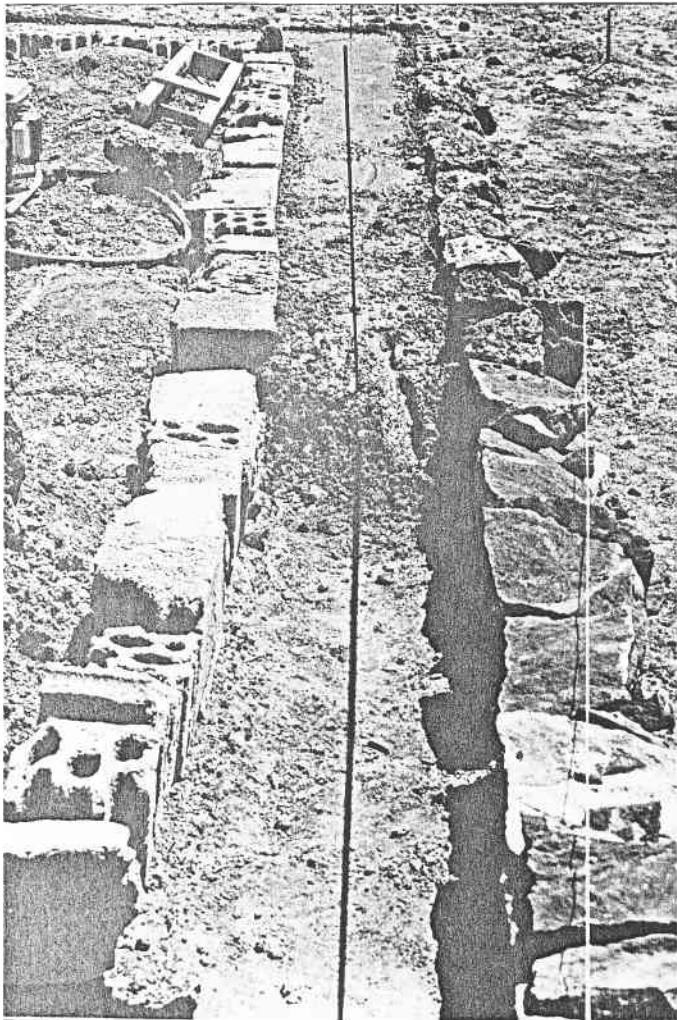
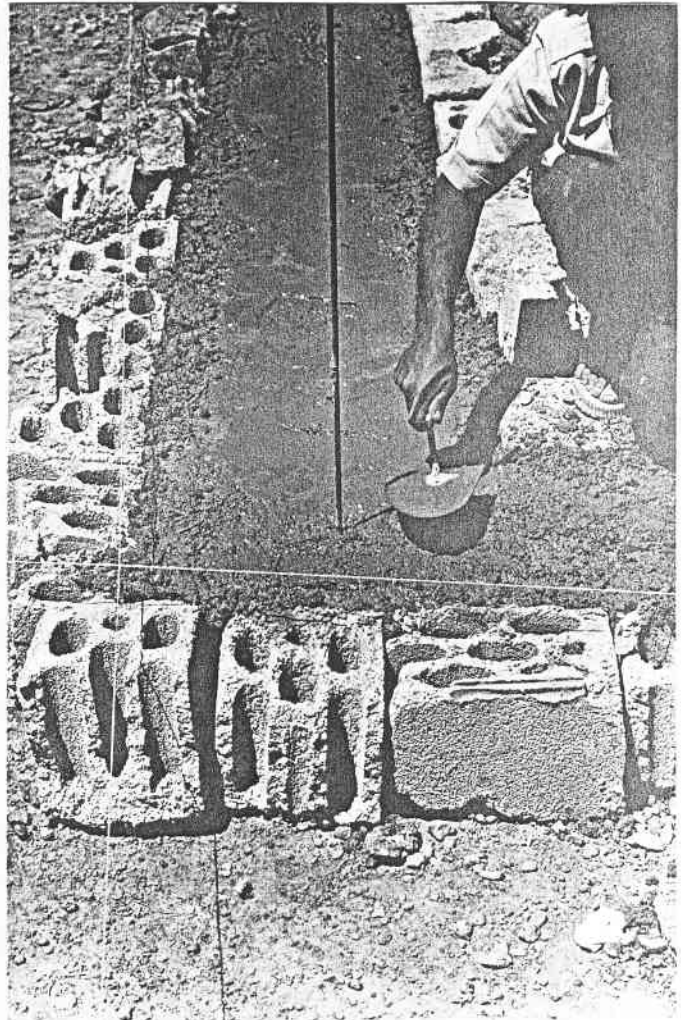
In order to cast the foundation strips at lower cost, two lines of broken cement blocks and stones were used for the other houses to cast the rough concrete layer, and to provide a flat working surface for the foundation tie-beam. The rough concrete was cast on the uneven ground surface and the vertical reinforcements were placed in this concrete. The total width of this first leveling course is more than the required wall thickness. For softer soils the foundation should be made deeper and the footing should be made wider. After hardening of the concrete the stones were removed and used in the construction of the walls.

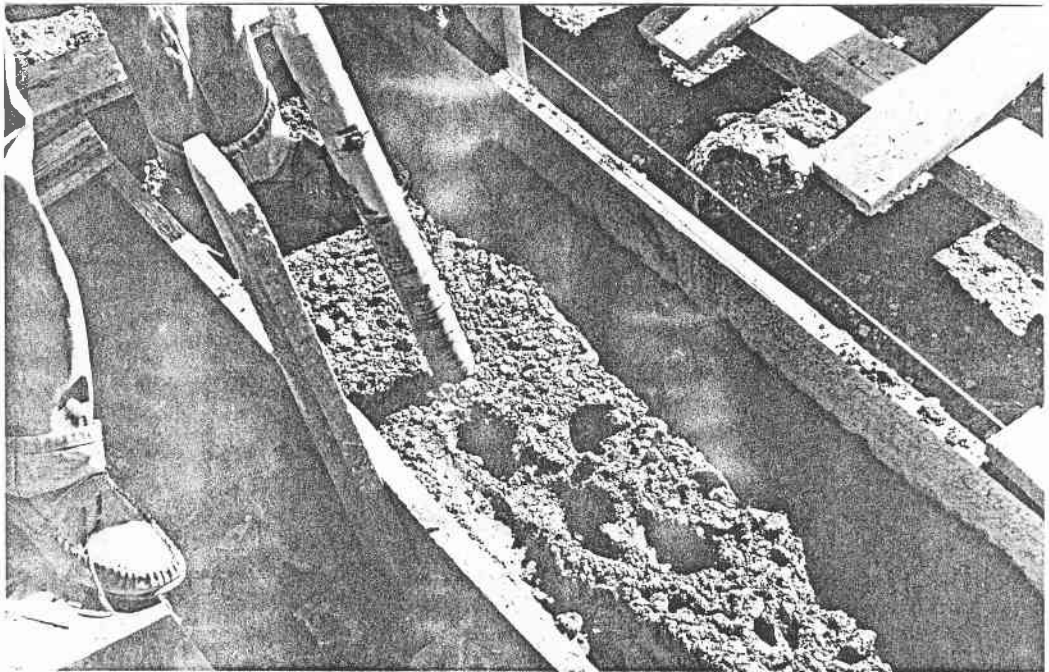
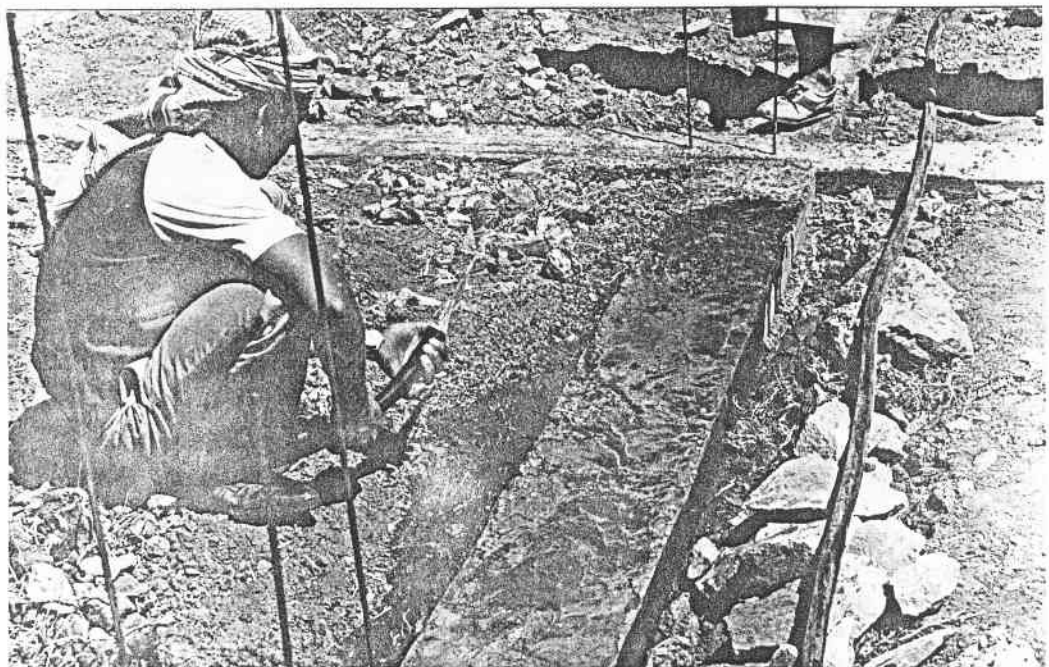
The mixing of the concrete was done with a motor mixer with a content of 200 liter. An effort was made to keep the water-cement factor as low as 0.5, and to obtain a high concrete quality by mechanical vibration. Due to water absorption by the volcanic stone and the high evaporation, the concrete mortar was too dry and even with prolonged vibration the concrete mass did not liquidize. The most appropriate water-cement factor in combination with the vibrator was 0.7.

After the casting of the foundation strip, the same was kept wet for several consecutive days.

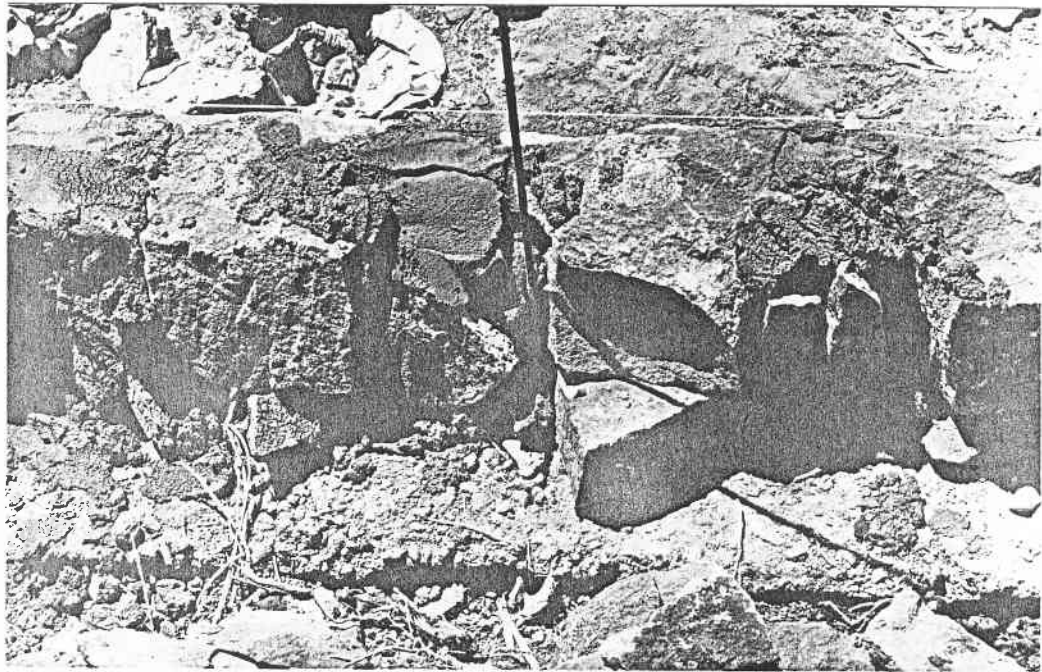
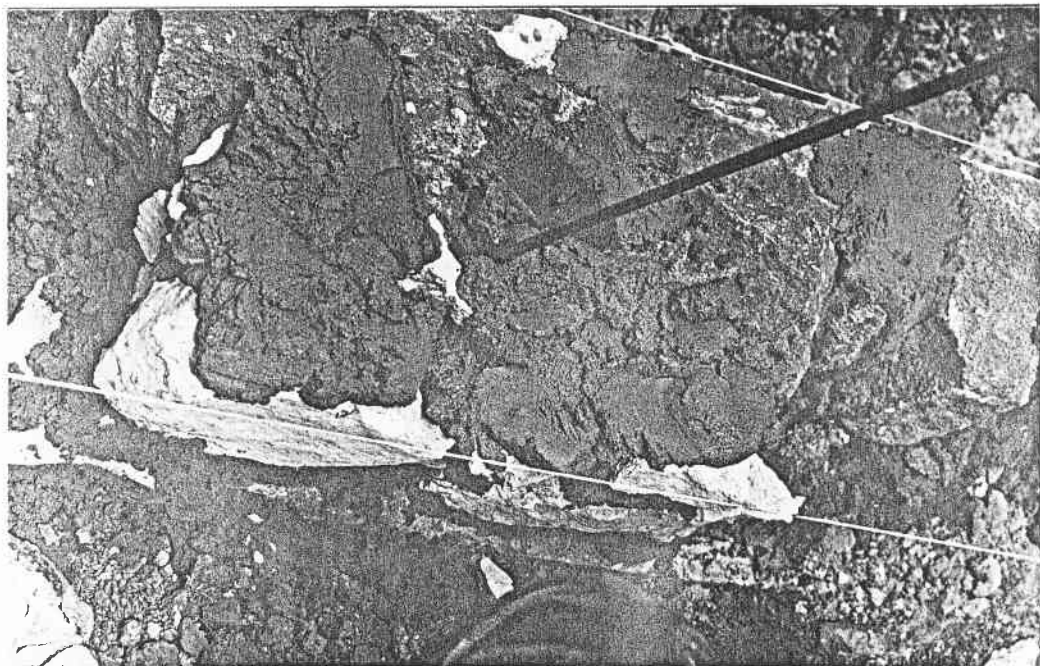
The first layers of the foundation upto floor level were made in black tuff stone, and the stones were laid around the vertical reinforcement bars.

The stones make often contact with the reinforcement bars and may cause corrosion, particularly because the foundation may retain long time its humidity after rains.

If the reinforcement bars have to go through stone masonry, they should be cast in concrete, which does sufficiently surround the bars on all sides. A proposal has been made to separate the bar from the stone during the masonry with a (temporary) 10-12cm plastic pipe.

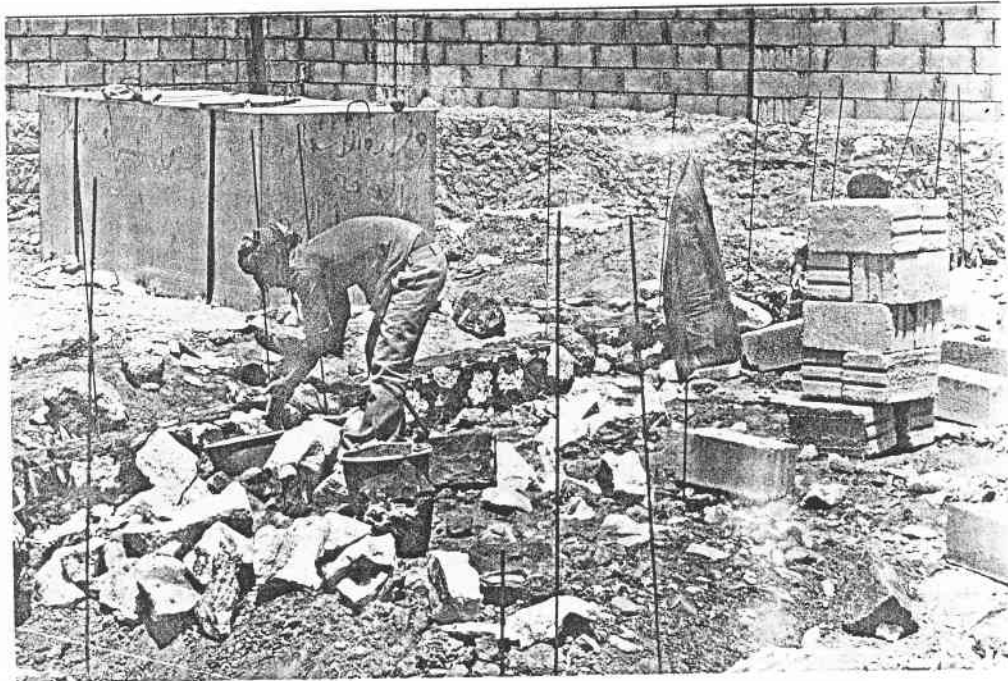
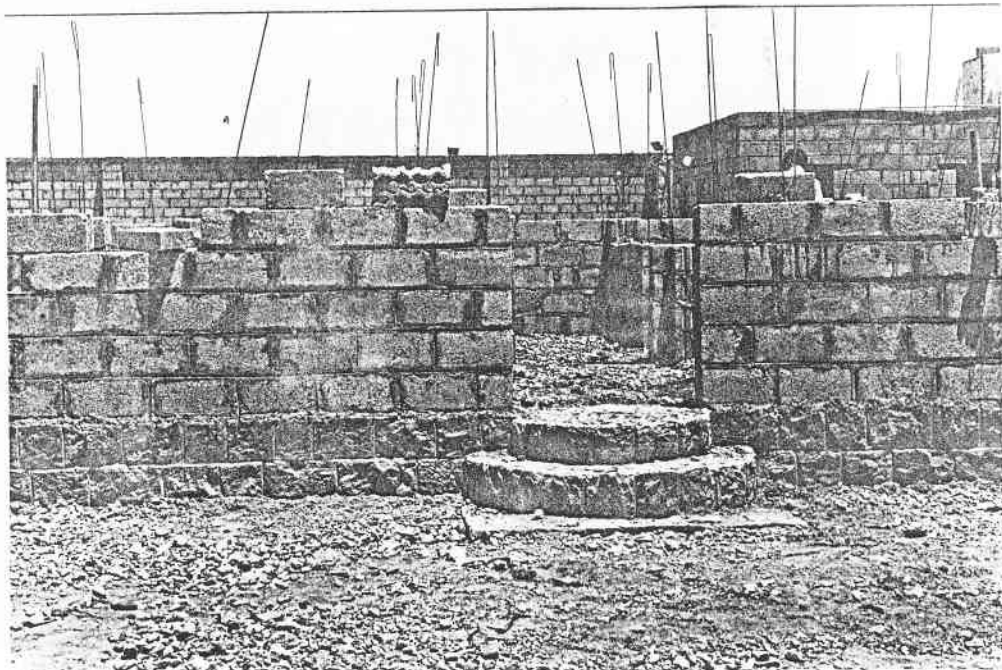
In the cement block house a single vertical reinforcement bar was placed at every opening of door or window. At the corners and intersections of the walls an additional bar was placed.

The position of the bars was planned to correspond with the holes in the hollow cement blocks, but because of the use of natural stone in the foundation this coordination was partly lost. It is not recommended to make a stone foundation for a cement block house, but to use exclusively solid cement blocks in the foundation.

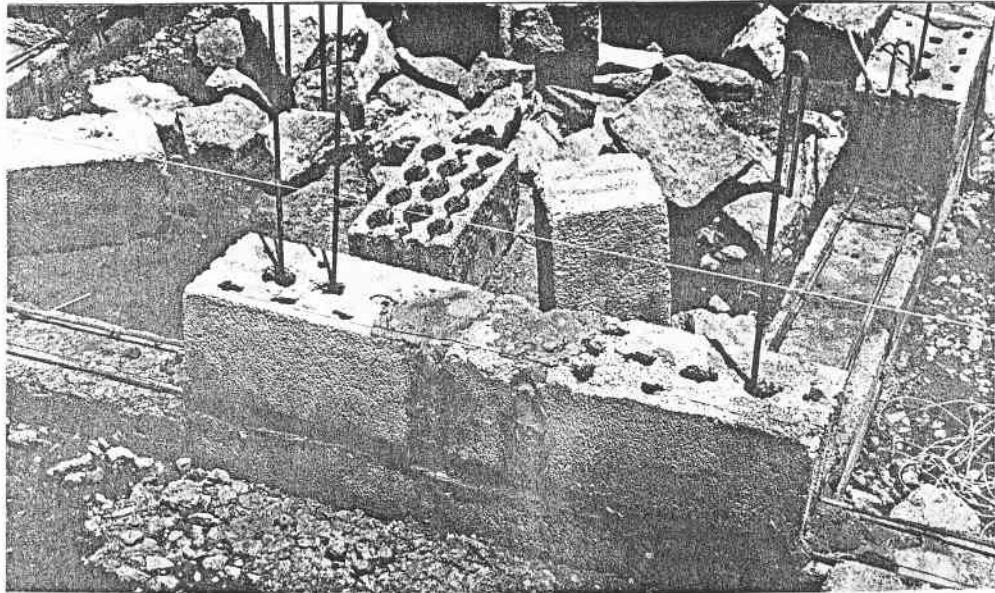
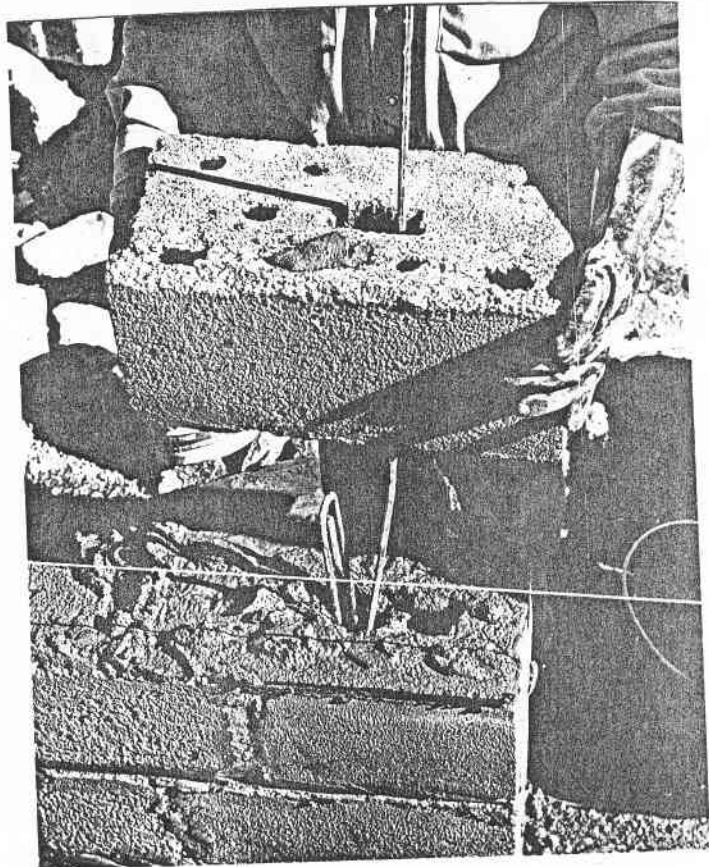
Contrary to the design the 11 holes cement blocks were used as hollow cement blocks in order to pass the reinforcement through.

The results were that it is not possible to keep the correct position of the bars, and the filling of the holes with concrete could not be properly done.

In some cases the holes were not filled at all and in other cases the holes were filled with masons mortar. In both cases the covering of the reinforcement bars with strong cement mortar of sufficient thickness was not achieved.

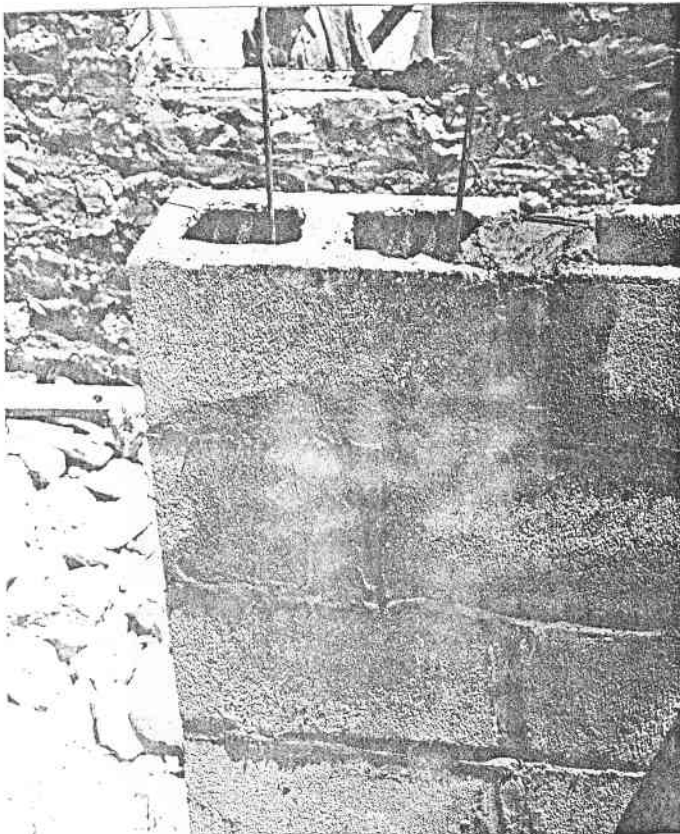
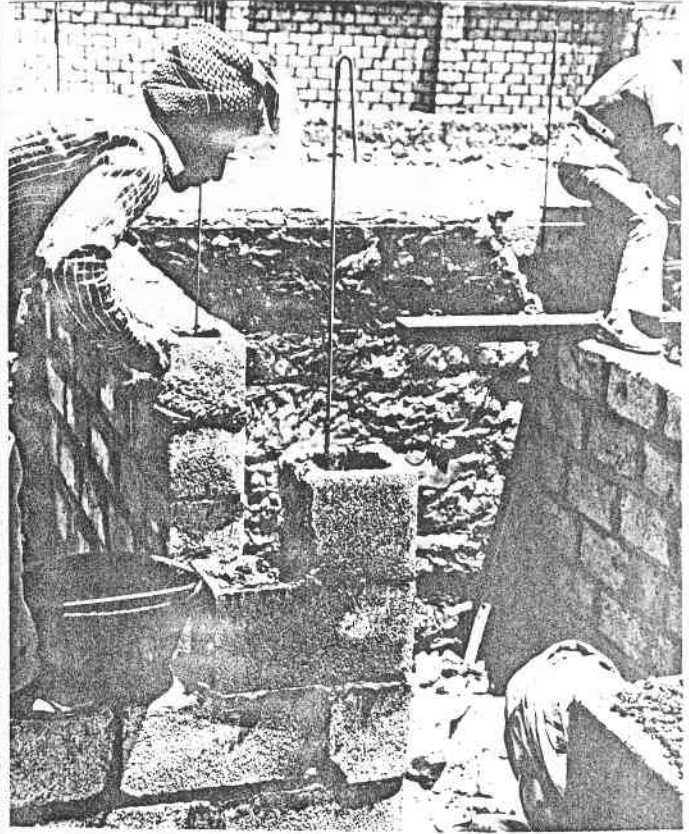
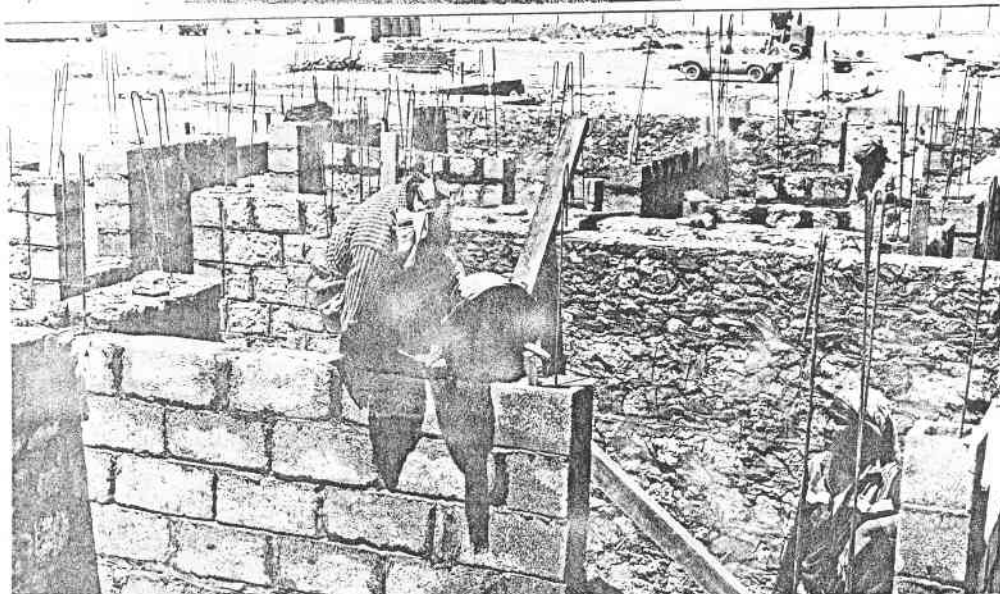
At those places where a vertical reinforcement bar was planned, a B shaped hollow cement block was placed, which was filled after each course with concrete with fine concrete. The maximum aggregate size had to be  $1/2"$  or 1-1,5cm.

The concrete was rather liquid because the very dry and porous cement blocks absorb a lot of water. It was necessary to water the cement blocks sufficiently before the concrete was cast.

The B shaped cement blocks formed this way a strong framing of the openings.

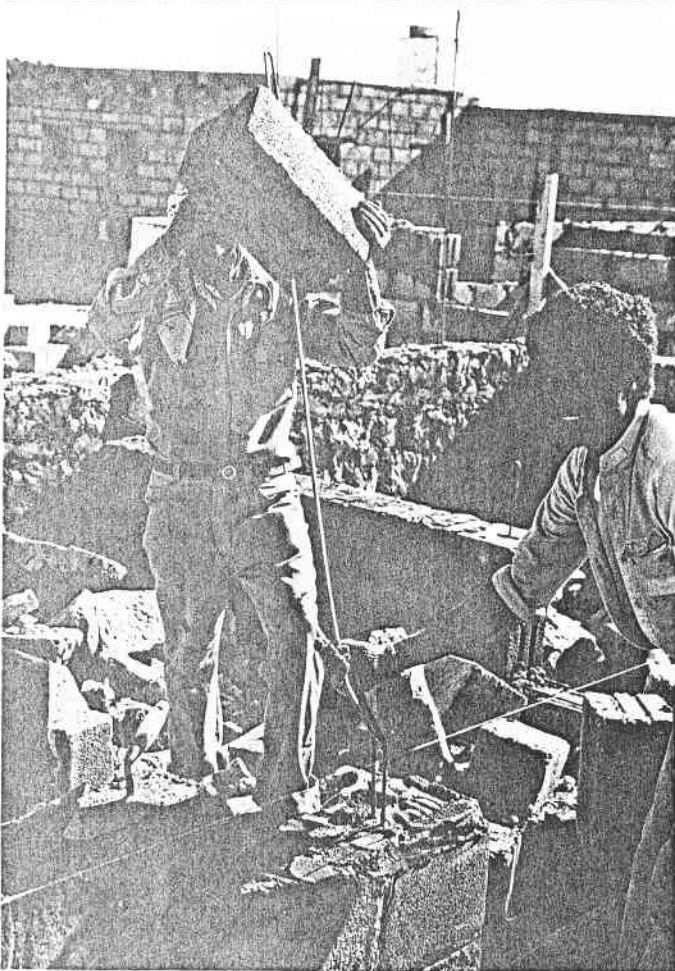
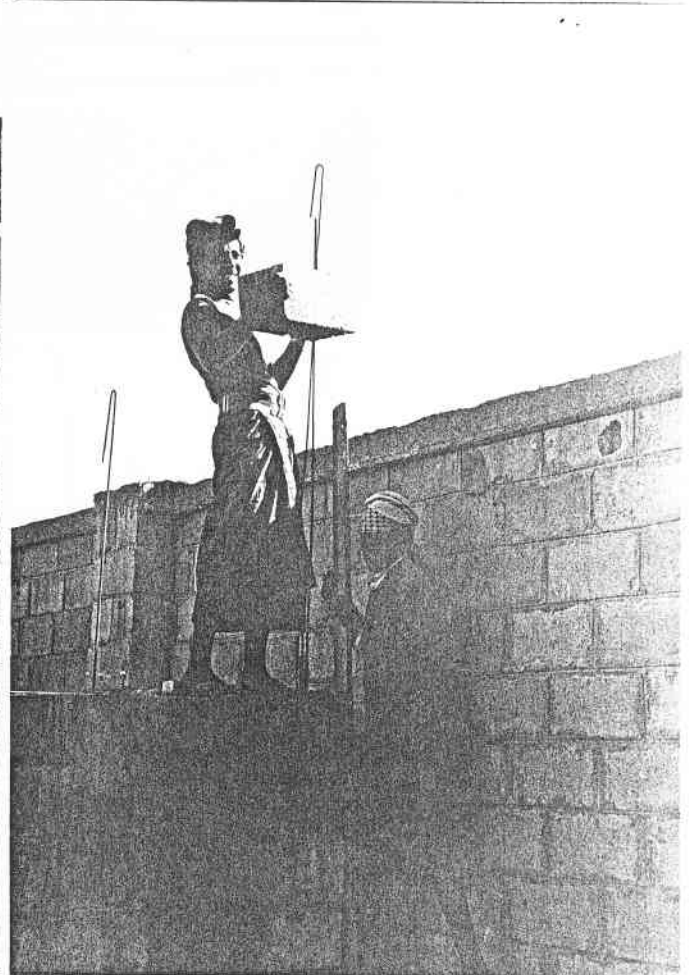
The vertical reinforcement bars have a diameter of 8mm or 10mm at the most. The 6mm vertical bar will too easily bend. When working at a higher level, it became difficult to put the hollow cement blocks over the top of the bars, especially when this were the 11 holes blocks.

This problem is a small disadvantage of the system with the hollow cement blocks.

Another disadvantage of the long protruding lengths of vertical iron, was their swinging movements in the wind. These movements caused that the bottom of the bar, where cast-in, became separated from the concrete.

The solution to avoid these both problems was, to shorten the lengthening bars, and to have 4 lengths instead of 3 lengths in the height of the building.

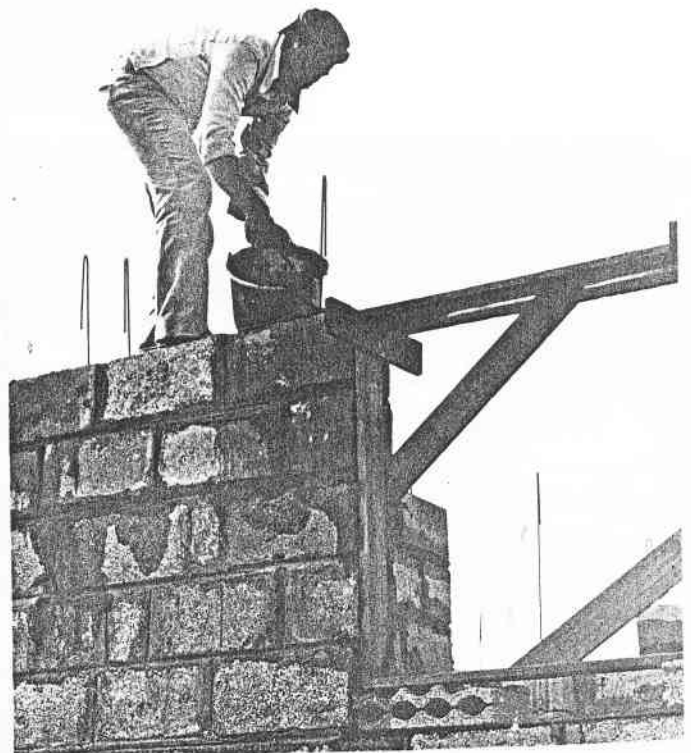
The U block beam was laid in a layer of very sandy mortar, and the temporary window frame had to be supported in the middle to avoid bending. On the upper side of the frame an extra plank had to be added in order to give sufficient support for the U blocks.

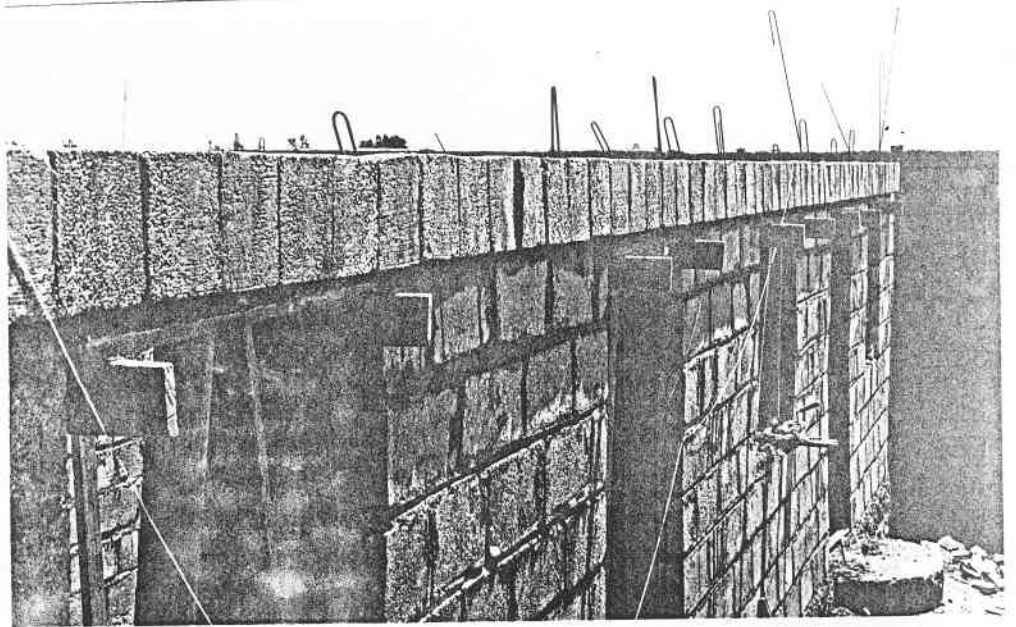
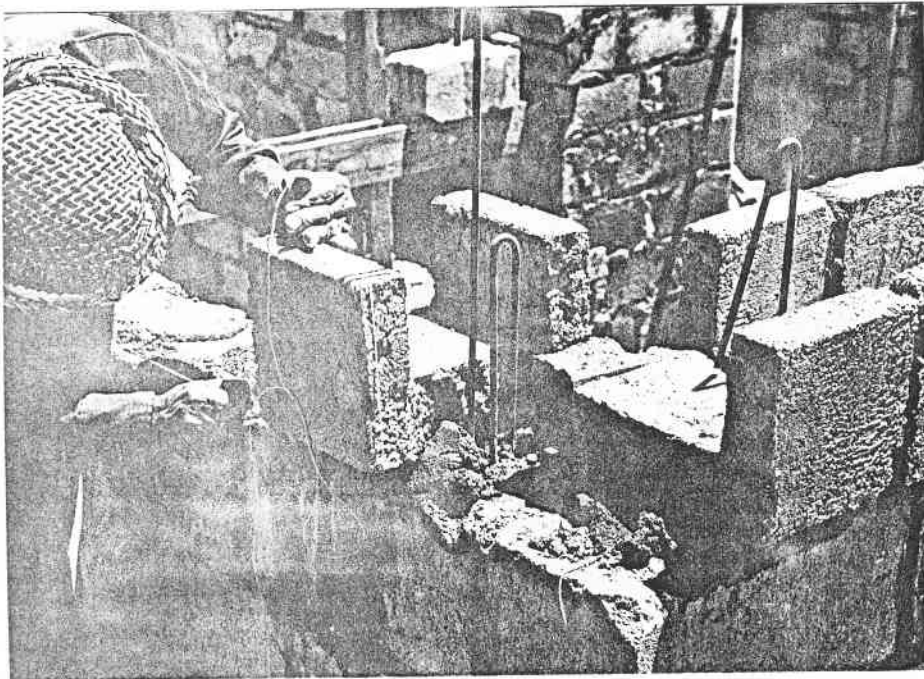
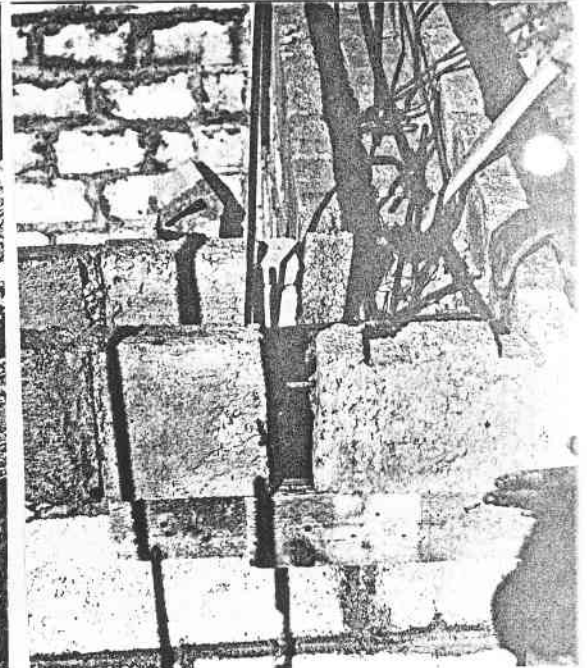
Over the outside perimeter of the cement block house an U block lintel beam has been made, but not over the inside walls, except over the inner doors.

In order to allow the vertical reinforcement bars to come through the U blocks at the right places, the horizontal bridge was partly cut away with a hammer.

The corner solution was made by placing a U block with one wing only at its side.

The little joints between the blocks were washed in with mortar in order to avoid leakage of concrete.

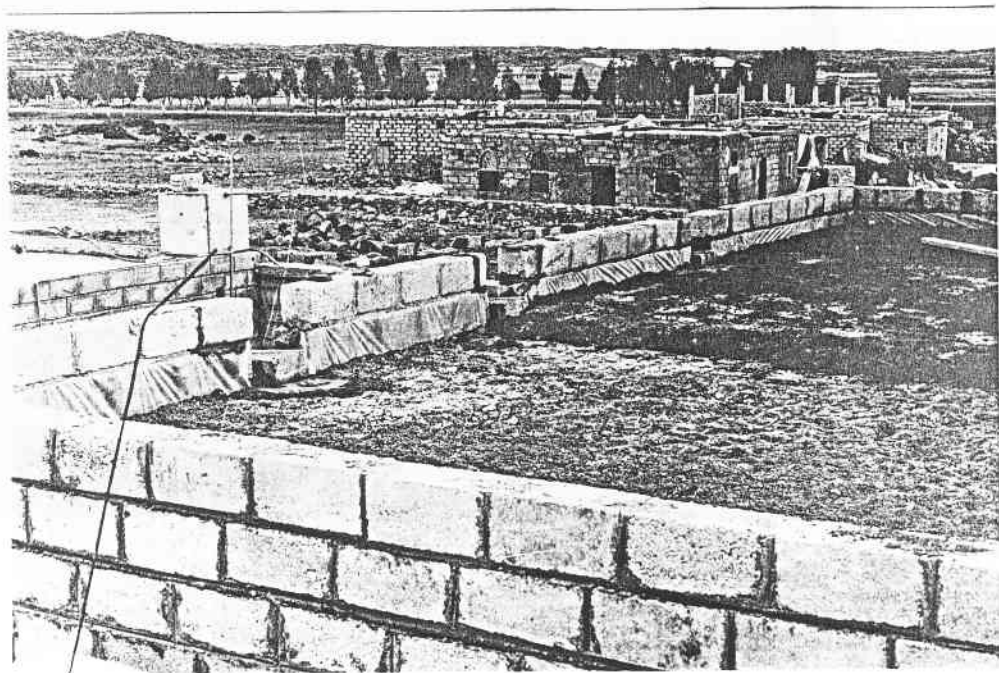
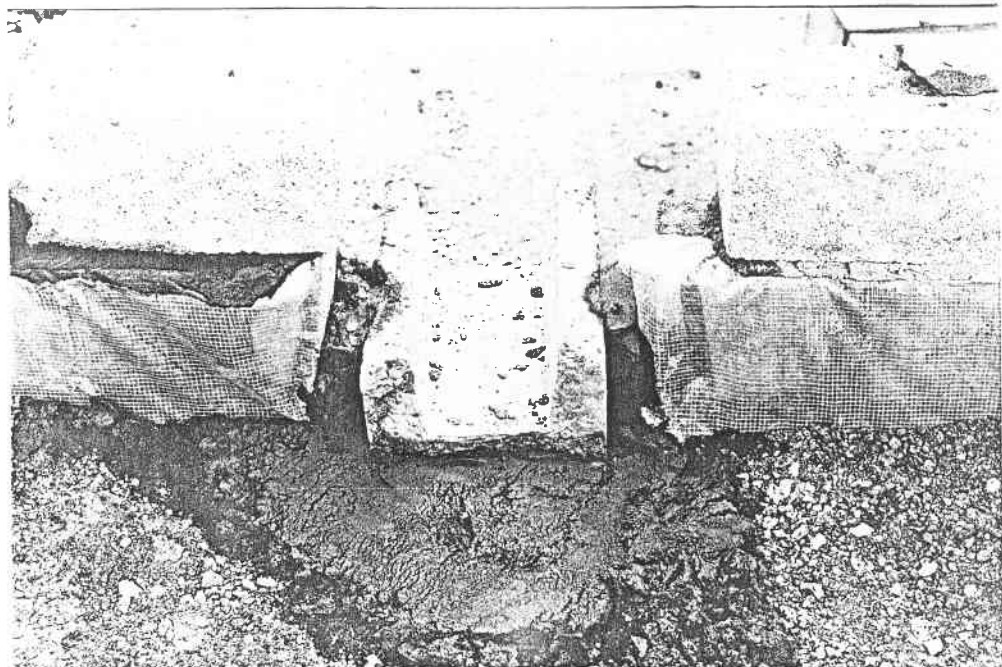
The impermeable roofsheet was placed with the sides up against the walls. The gutter piece was placed on top of this sheet where the wall was interrupted. This gave a barrier to the draining water. In the other houses the gutterpiece was placed lower, and the plastic made flush with the gutter.

The roof was filled with a stabilized mud layer (mixture 1 cement and 20 mudsoil), but the mixture of cement and the mud was made difficult by adding water. For the modelhouses in the project area a dry mixture of lime and mudsoil is recommended. The lime will harden itself with the moisture from the soil.

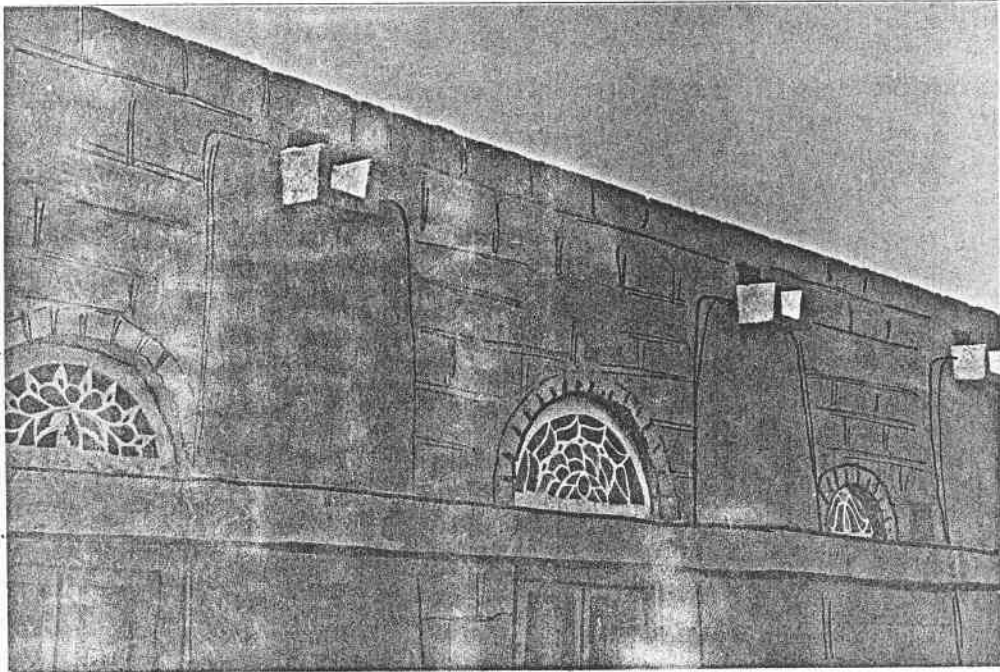
The cement block house was plastered inside and outside. The front of the outside was plastered with a smooth finish, whilst the backside of the house was brushed with a cement-sand mixture, thus leaving the general texture of the cement blocks in view. This last mentioned method is much cheaper in labour and material than the first, but gives adequate sealing of the porous cement block wall.

PLASTERED AGAINST  
LEAKING WATER OF GUTTER

COATED  
WITH CEMENTED BRUSH

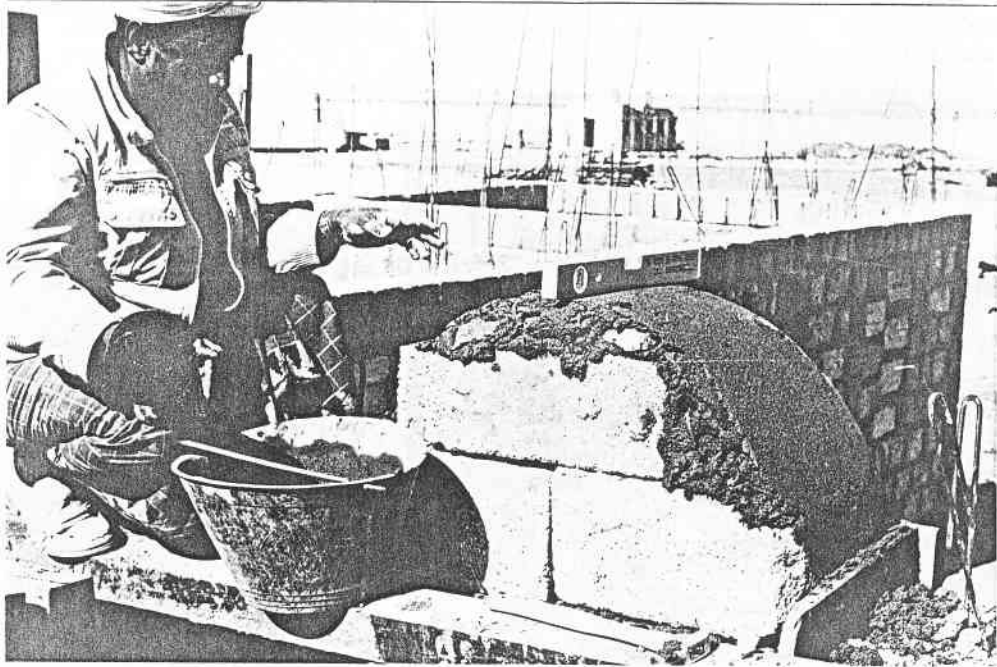
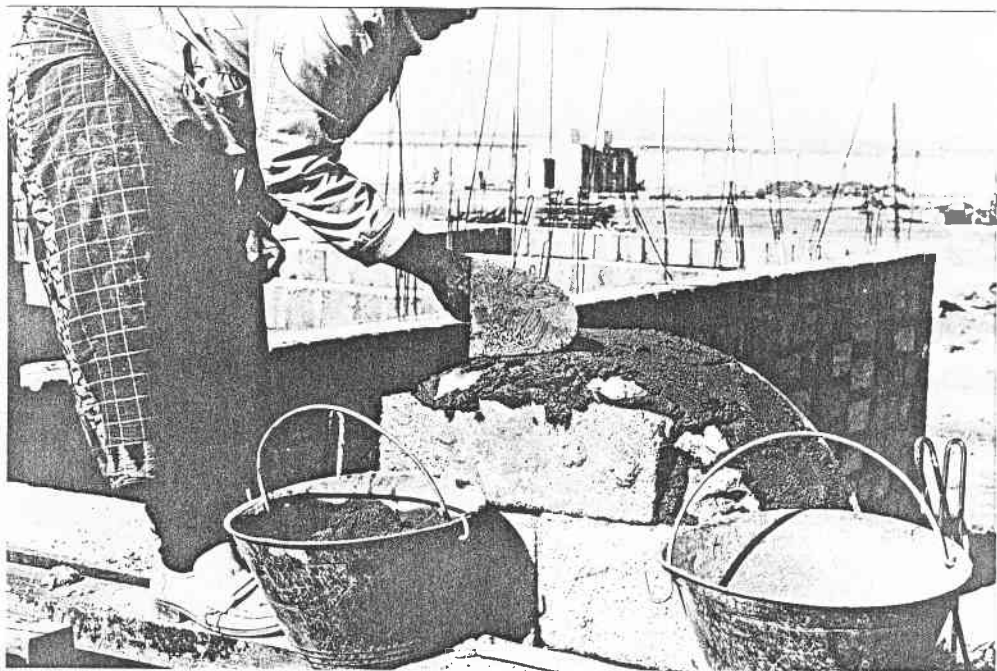
On top of the lintel tie-beam a series of traditional arched windows were masoned. In order to have a correct shape, a plywood half round form was made, against which an infill for the arch was made, using 3 cement blocks and a very sandy mortar. Care was taken that the formwork was made level. The production of forms was about 5-6 per day for a mason. Since this is too expensive (YR 50 per form), it is decided to make a metal form which can be reused many times. The seize of the doors and windows must therefore be standardized at a width of 90 cm.

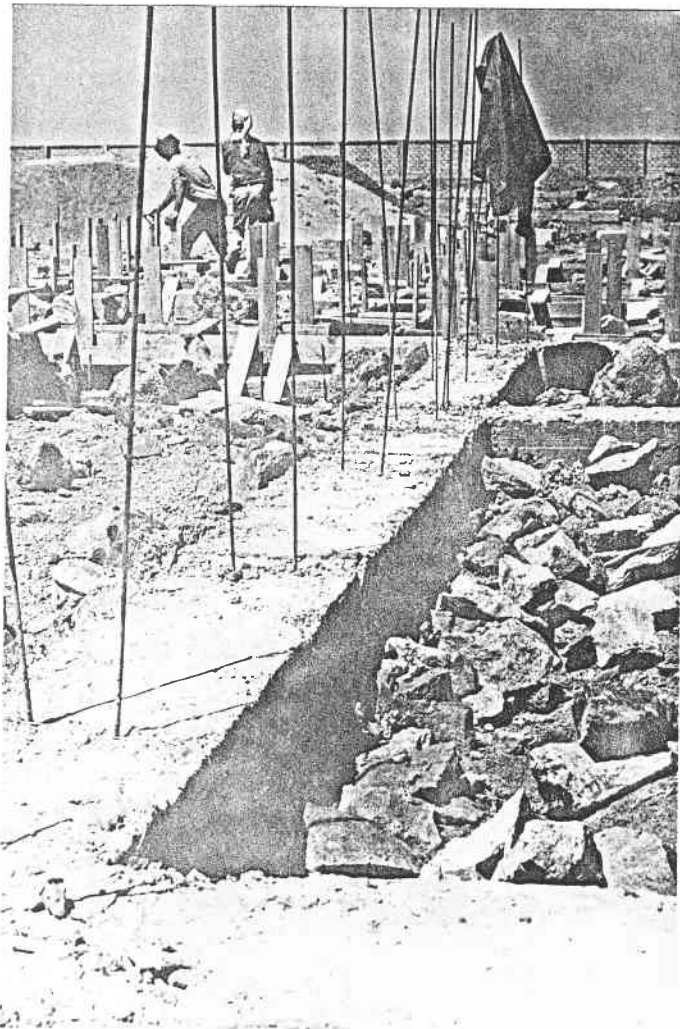
The double reinforcements are placed at the positions of the openings of doors and windows, as well as the intersections of the walls and the corners of the building.

The corners of the building are build up with solid 10cm thick cement blocks, with the stone masonry they form a hollow in which the reinforcement bars rise. Around these bars concrete can be cast easily.

After every completed horizontal layer all the hollows have to be filled with concrete, consisting of small seized aggregate. If many courses at once are filled with concrete and compacted with a rod or stick, the resulting horizontal pressure may push the cement blocks away from the stone wall.
