Dhamar Aided Self Help  
Reconstruction Project

SUBJ: VISUAL REGISTRATION OF THE BUILDING OF THE STAFF HOUSES  
PLANNING ACTIVITY NO 50.

Diskette: 650.NYN.ORG  
DHAMAR AIDED SELF HELP RECONSTRUCTION PROJECT  
FILE: 3.4160.62.03  
DATE: 29 JULY 1984  
SUBJ: VISUAL REGISTRATION OF THE BUILDING OF THE STAFF HOUSES  
PLANNING ACTIVITY NO 50. (addition to house construction 1)

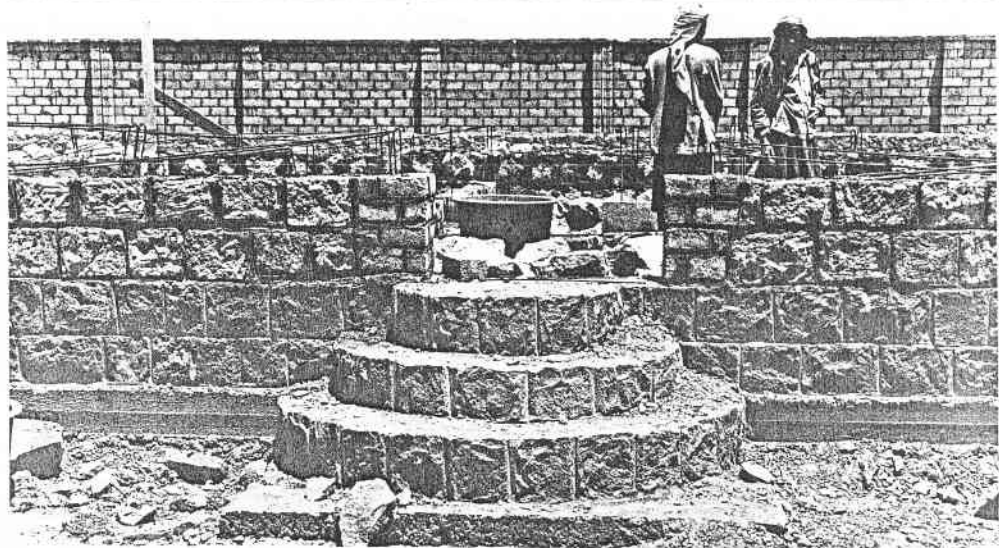
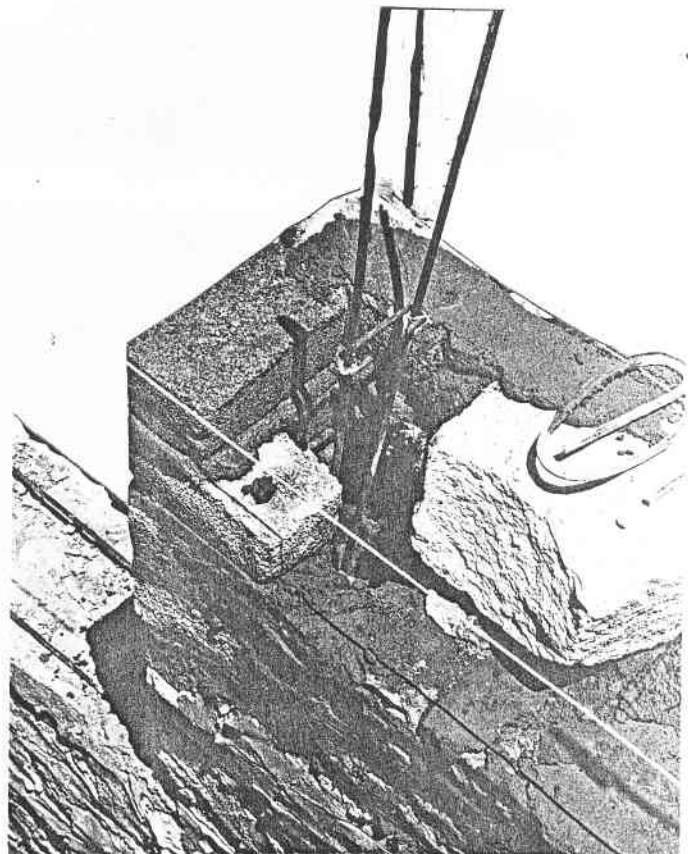
On the sides of the doors and windows smaller size cement bricks were used 7x10x20cm, to form a straight vertical border for the stone masonry, as well as a vertical channel for the vertical reinforcement.

Horizontal ties held the bars apart, but the double bars at the door and window openings were further considered as excessive and cumbersome to work with.

The openings were not masoned with a frame in the opening.

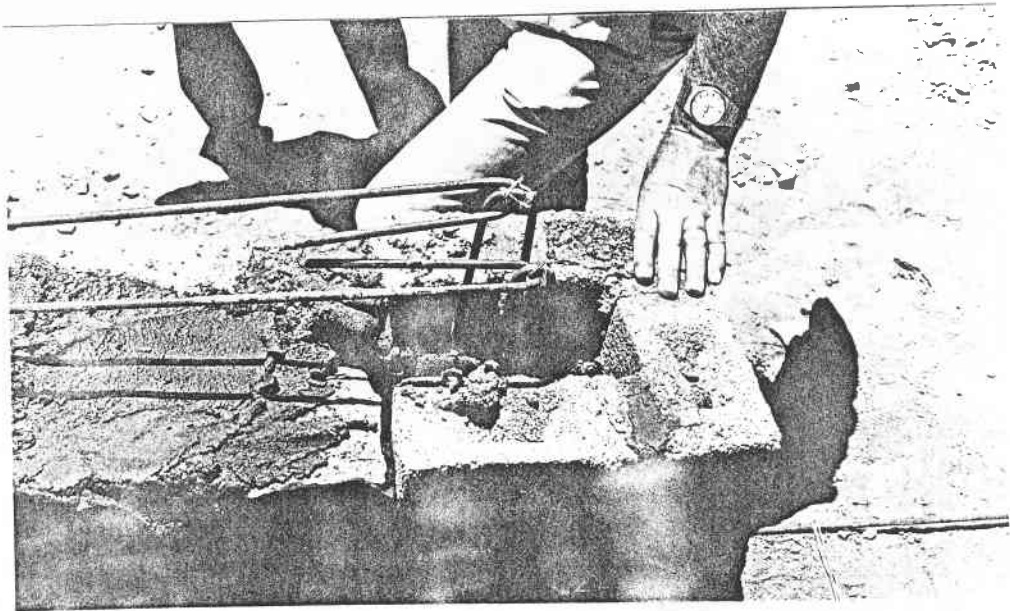
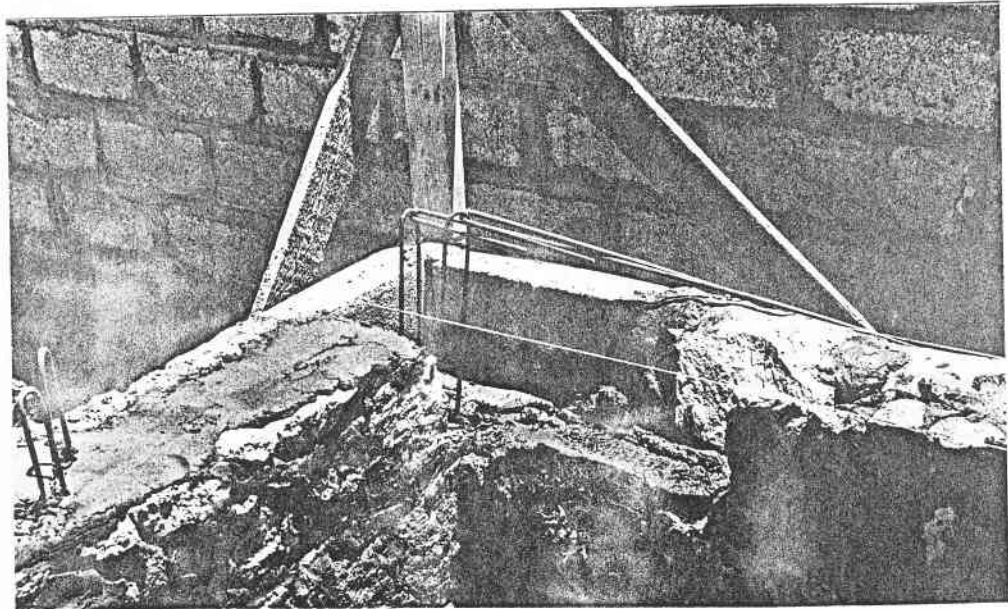
For lengthening the bars, a choice was made between an overlap of 30 times the bar diameter or a hook on both bars. The overlap should have been made by pushing the lengthening bar into the fresh concrete, next to the other bar. Because the real overlapping length will with this method not be good controllable, the preference was given to the double hook.

The minimum considered length of each hook is to be 20cm, and sufficient concrete should be poured all around the bars.

Some strength test have been executed on samples and the hooklength of 20cm showed to be sufficient, only when the concrete had a cross section of minimum 10 cm.

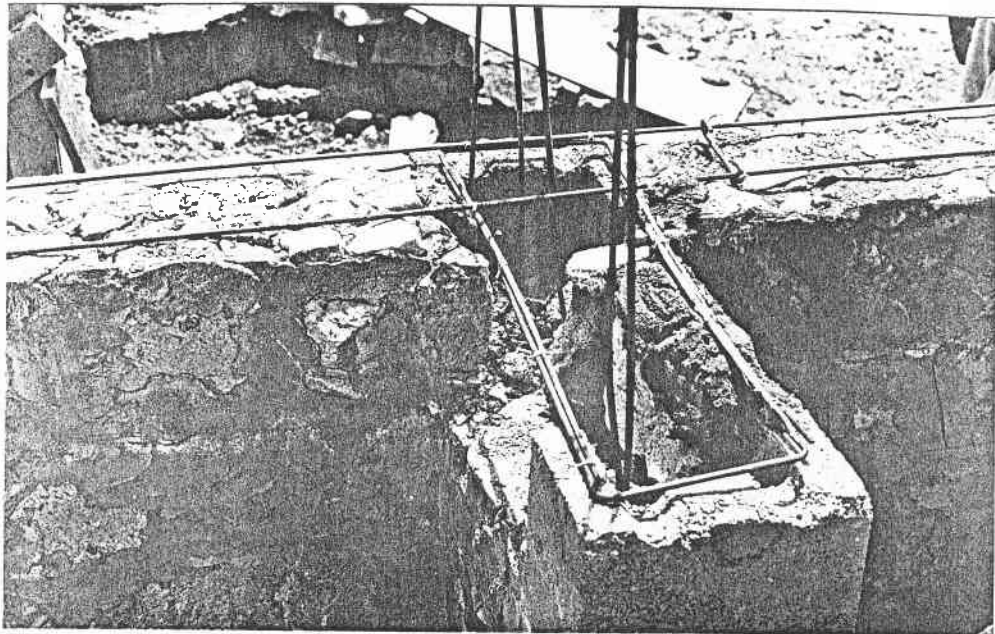
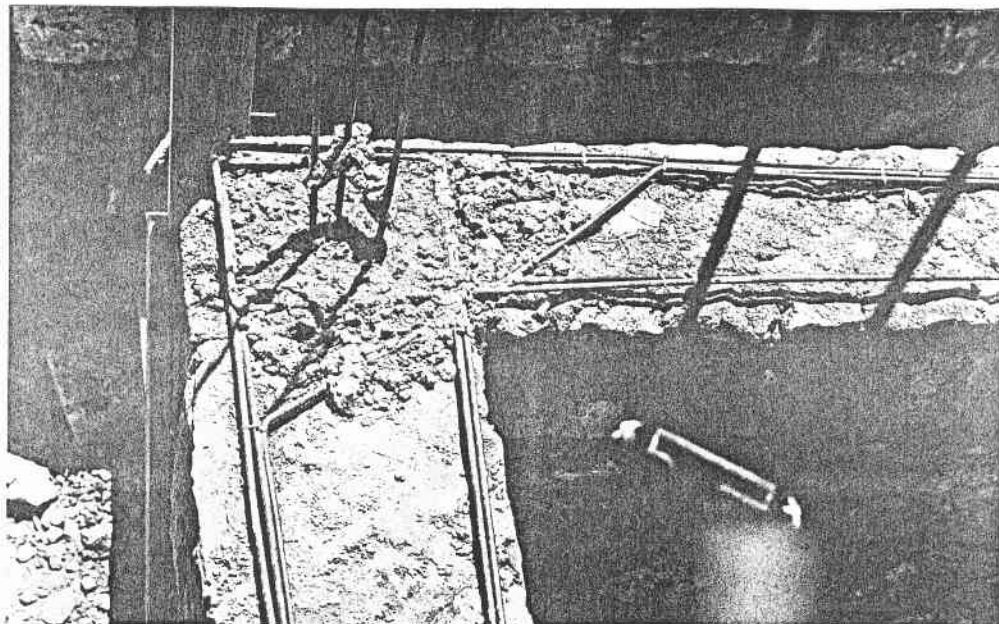
Below window level horizontal reinforcement was placed in both the stone wall houses, however because of lack of 6mm steel bars the much more ridged 8mm bars were used.

Although horizontal ties were specified every 40cm, they were nearly not placed at all.

Over the corner an extra diagonal bar was placed. This diagonal bar was repeated in all lintel beams.

In all corners the hairpin bars are kept continuous, with the overlap of minimum 30 bar diameters in the length of the wall.

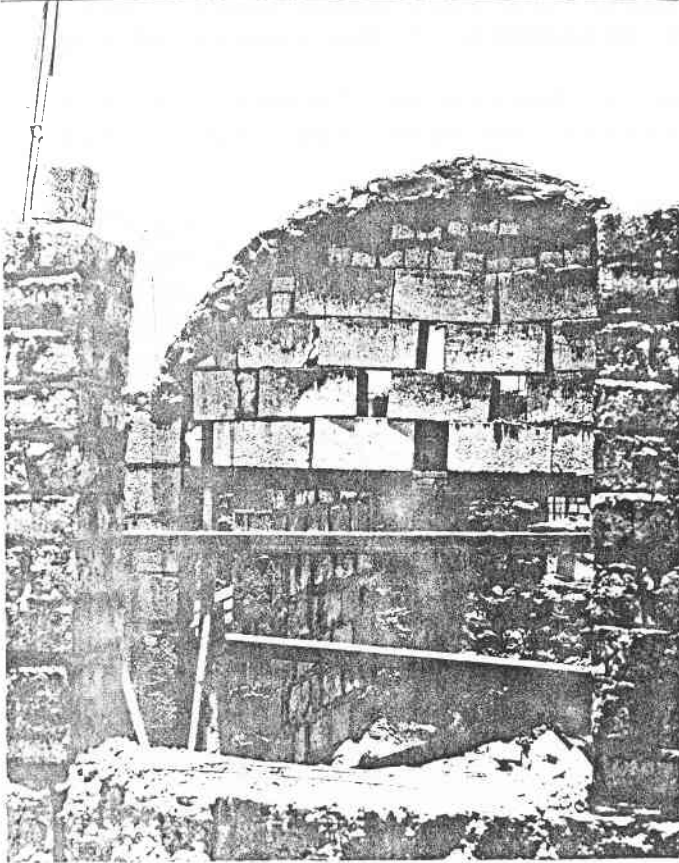
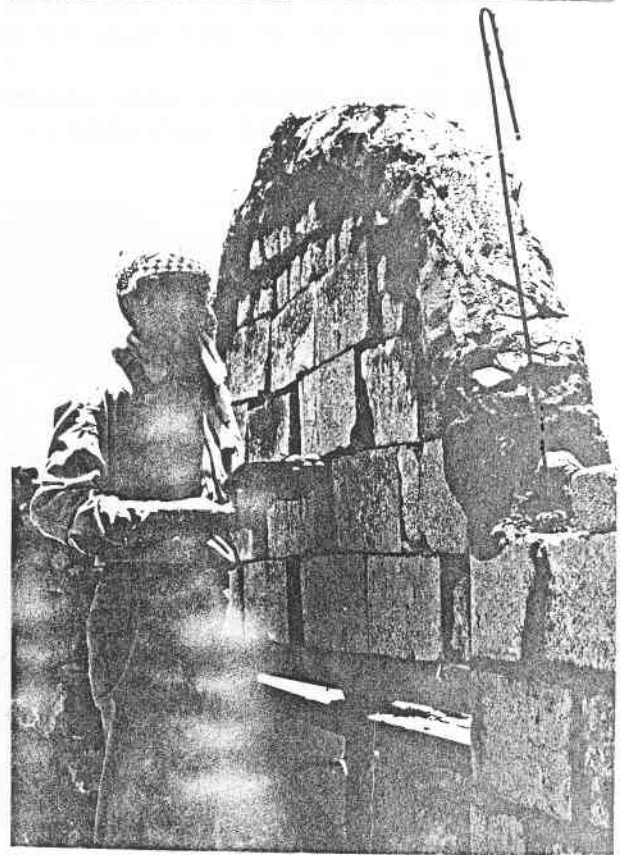
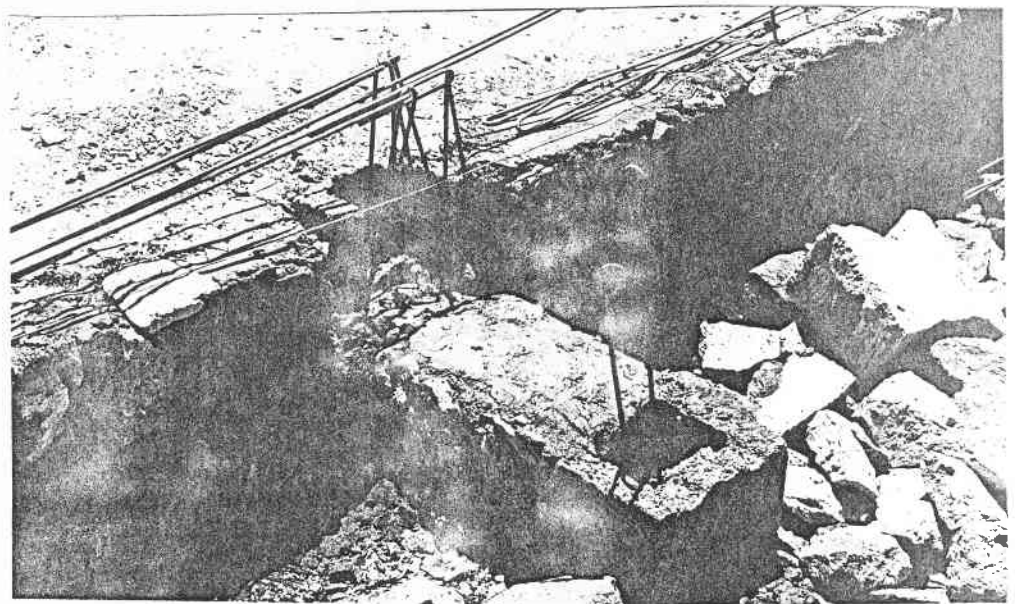
A temporary mould was made to mason the large arch inside the house, connecting two rooms together. The timber formwork support had a height of 1.50 m and the total height of the arch was about 2.50 m. The bottom picture shows the basis of the pier against the outside wall.

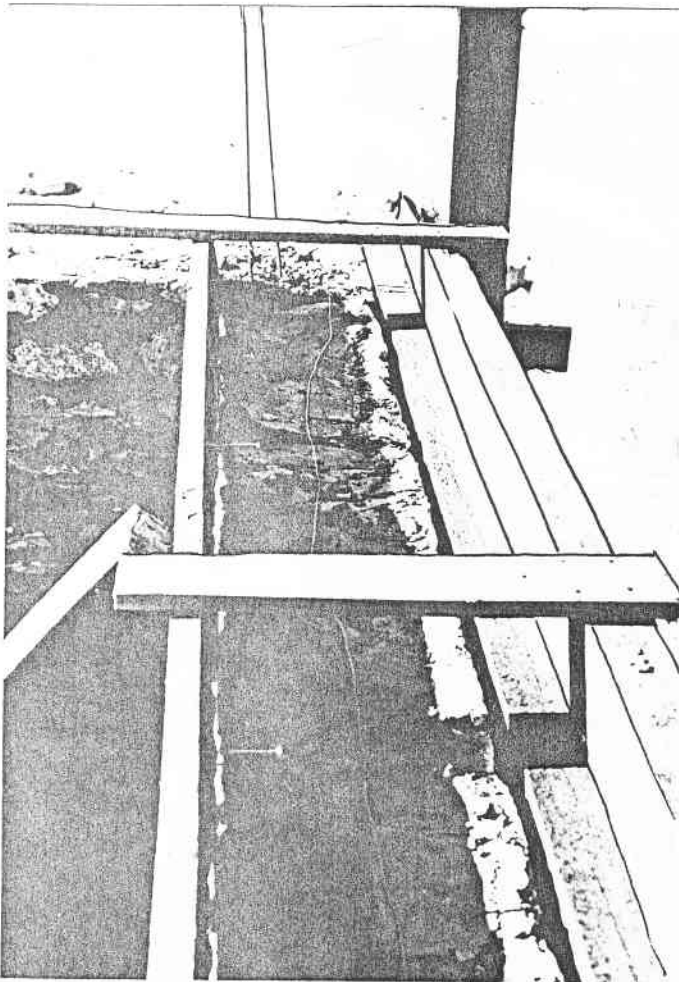
In the middle house a tie-beam was made by means of a wooden formwork, consisting out of the straight floor timbers. Many spaces remained between the timbers and the sides of the wall.

On the inside of the tie-beam a plank was cast in and held in position with large nails.

The disadvantages of the making, and afterwards repairing the wider tie-beam with the timber formwork does not make it an advisable construction. The wider tie-beam is more ridged than the smaller U-block beam, but much more costly in labour and materials.

WIDE BEAM  
TIMBER FORM  
HOUSE II

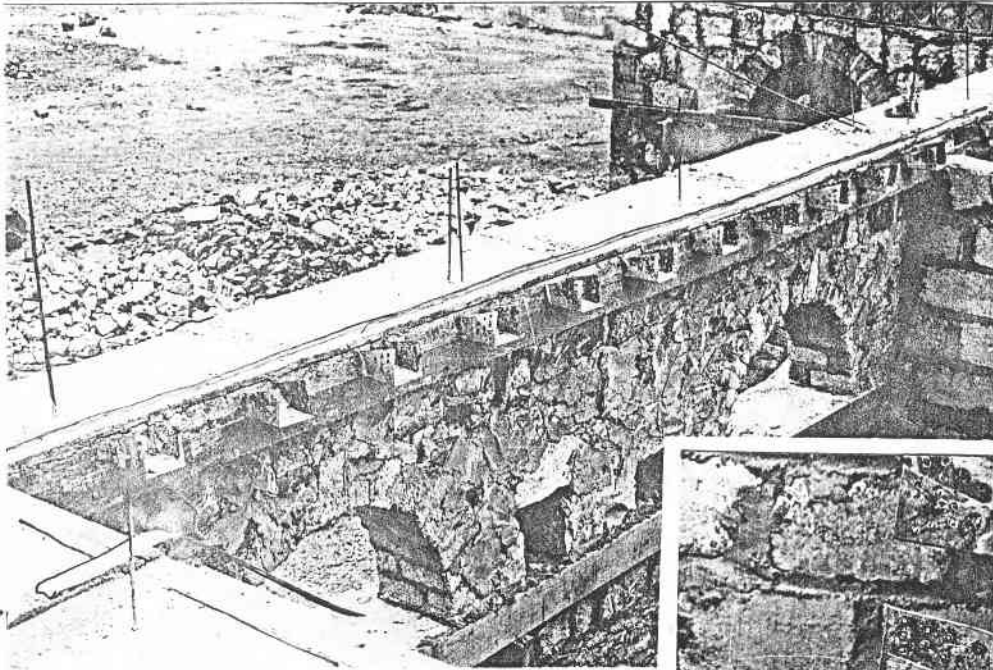
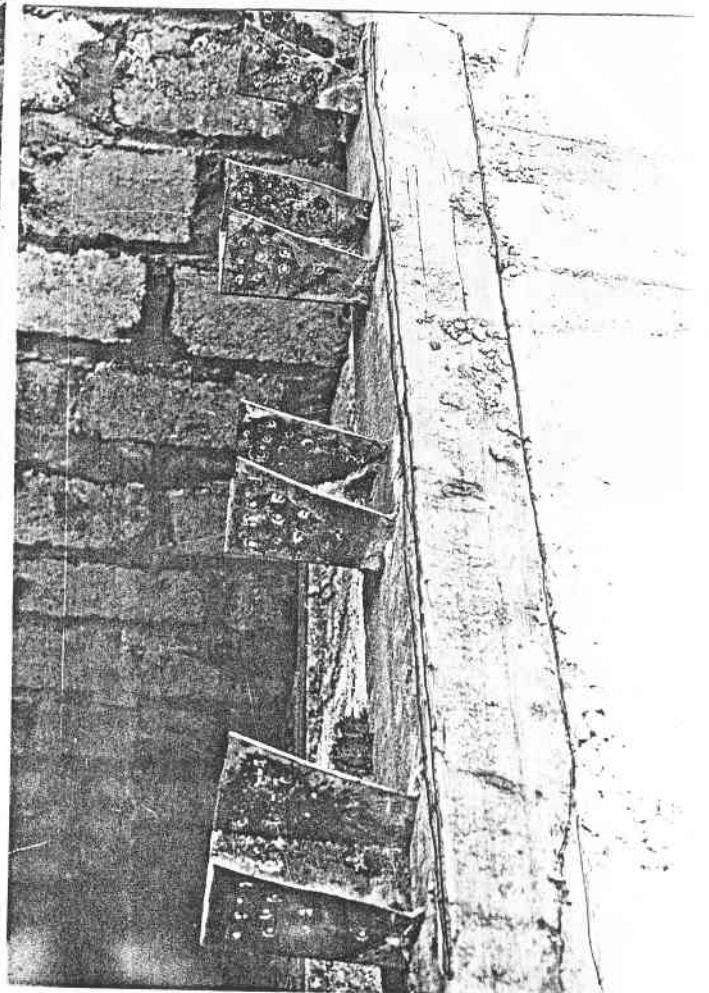
In order to make a good connection for the floor joist to the highest tie-beam, special shoes were designed, consisting of folded galvanized metal sheet metal with 10 nail holes on either side. However the nailholes were burned into the sheets and thus very rough. For the nails, concrete or hard steel nails were used in order to enter the hardwood joists.

On top of the shoes, a plank was cast into the tie-beam, for the fixation of the plywood onto the tie-beam. The plank was anchored with a large number of nails into the concrete beam. The whole construction proved to be very good but expensive and complicated.

SIDE STRAP  
ANCHORING FOR JOISTS  
SEE ALSO PARAGRAPH 4.7.

The side connection of the floor joists parrallel to the wall was achieved by galvanized metal straps, which were cast into the higher tie-beam and nailed with concrete nails to the bottom of the two first beams.

The nailing from the bottom appeared to be difficult and it was suggested to place the steel straps in future between the joists and the plywood. As a further simplification it is suggested in the modelhouse to apply a double wide galvanized wire mesh in the wall and nail only the first beam to that wire mesh.

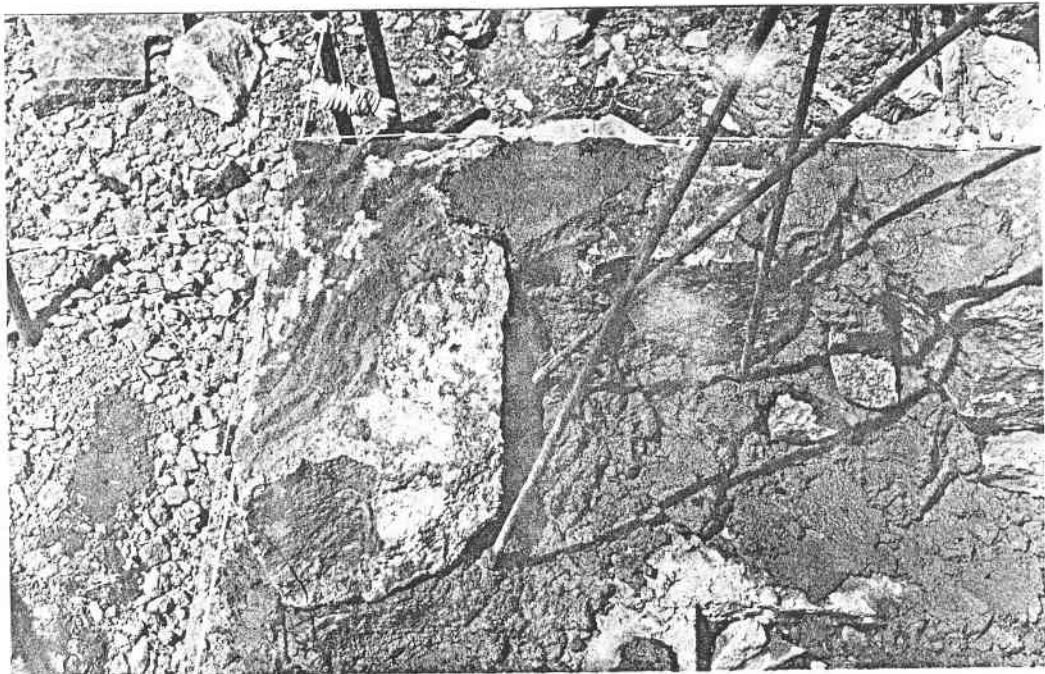
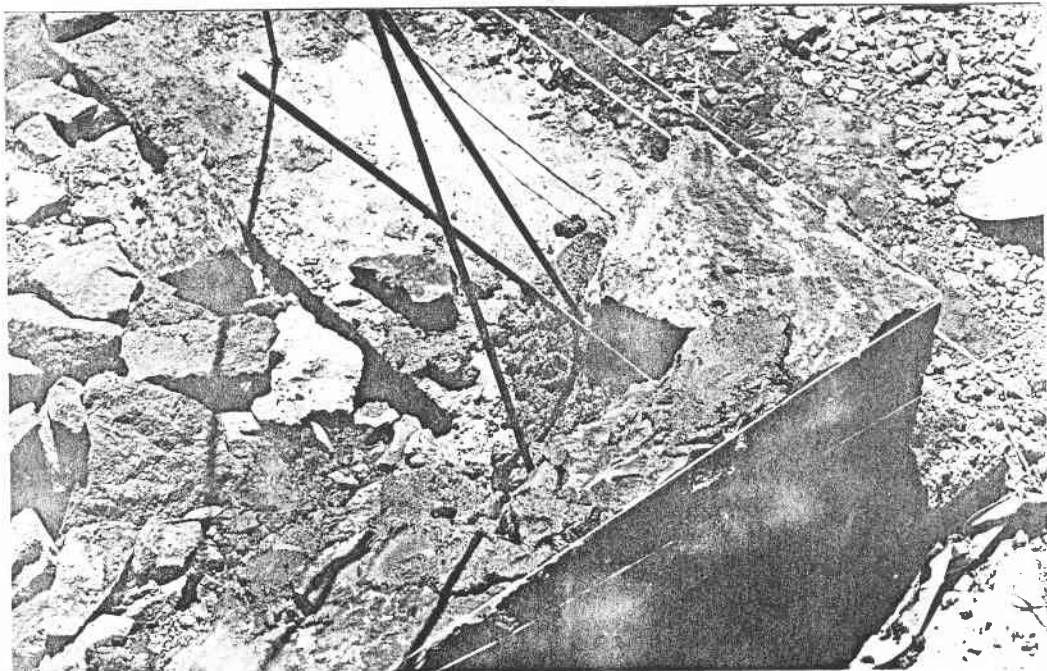
The design of the house had three reinforcement bars in the corners of the walls. Because no U blocks were used in the foundation, the bars came both into direct contact with stones and were bent sideways to give place to the stones. Also the reinforcement bars were only surrounded with the normal masonry mortar.

The use of three reinforcement bars is excessive for only a house without a story or a one storey house.

The U shaped cement corner blocks should be used from the foundation up.

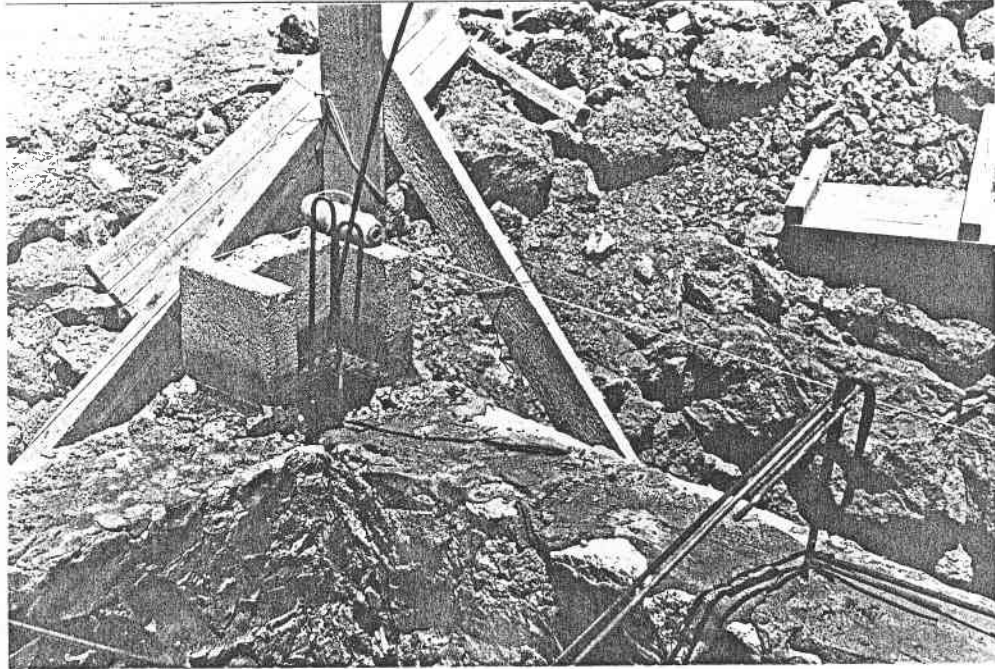
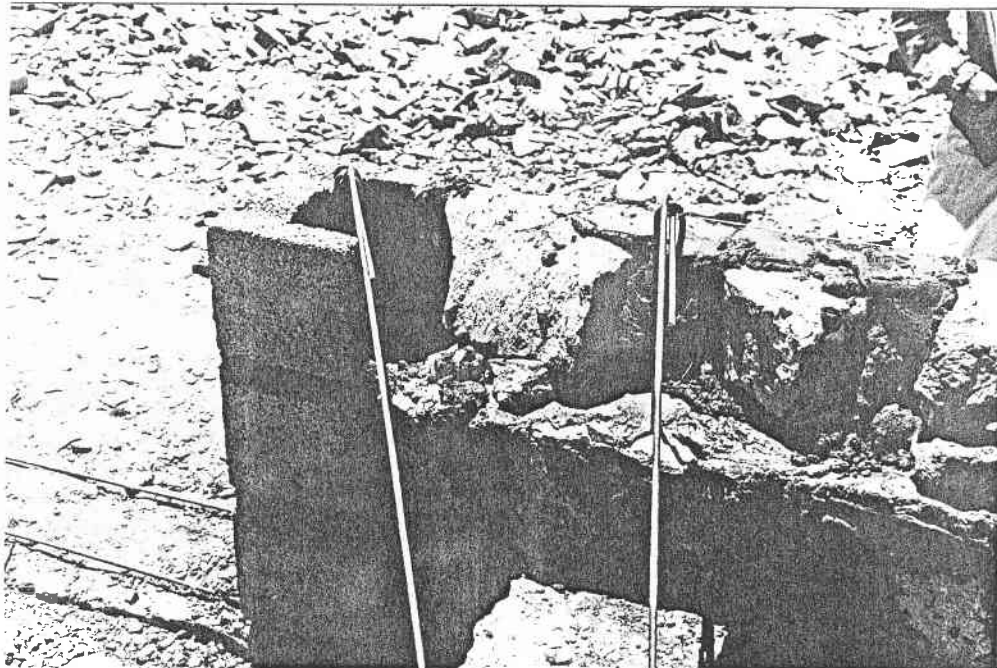
Alongside of all the doors and window openings one or more vertical reinforcement bars were designed. The spacing and the exact positioning of the bars was not maintained. Under the windows no U blocks were used, so the bars were masoned directly into the stone wall, with the fore mentioned disadvantages of contact with the stones. The following pictures show the first hooks between the two lengths of bars, as well as the grouping together of the two bars.

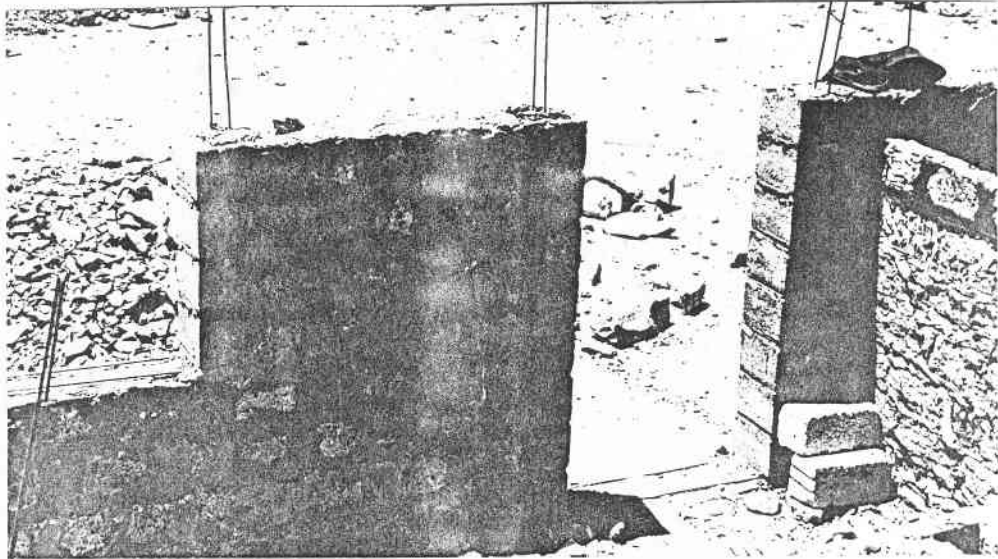
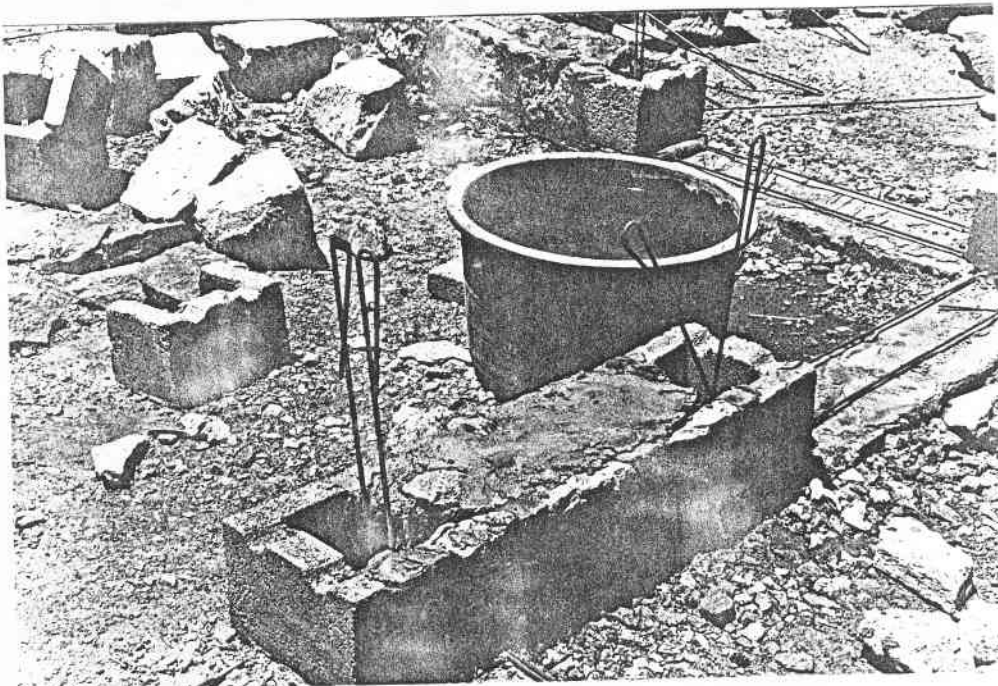
Under the door openings and under the window openings a double horizontal reinforcement was placed, from which the reinforcement under the door openings came directly over the foundation and thus is less useful.

For the making of the openings no temporary frames are used and compared with the other two houses the measurements were kept more exact.

Water was constantly supplied in order to keep wet the masonry work for several consecutive days.

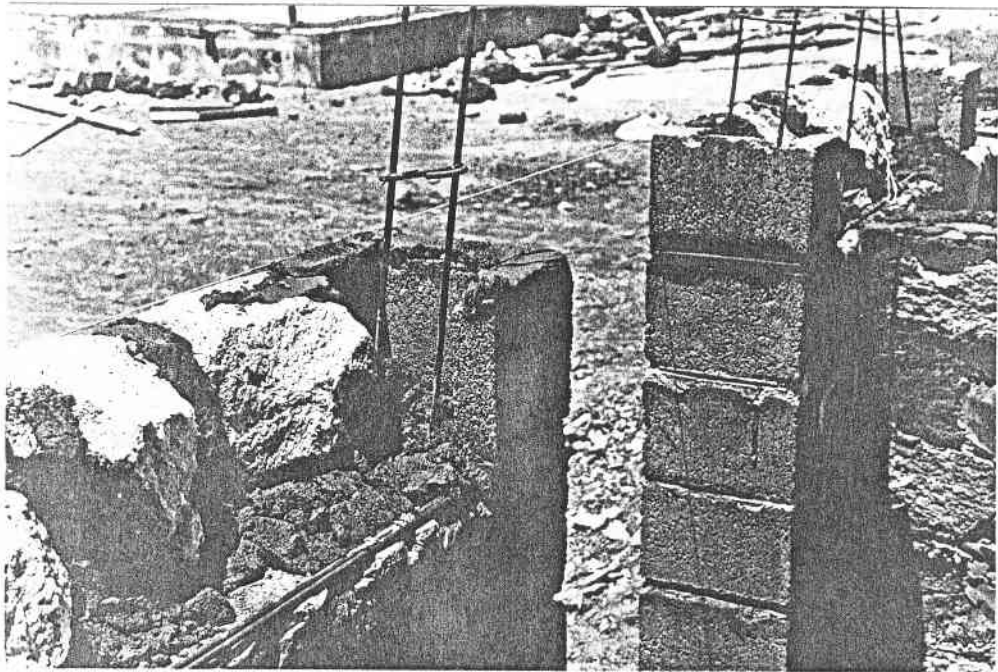
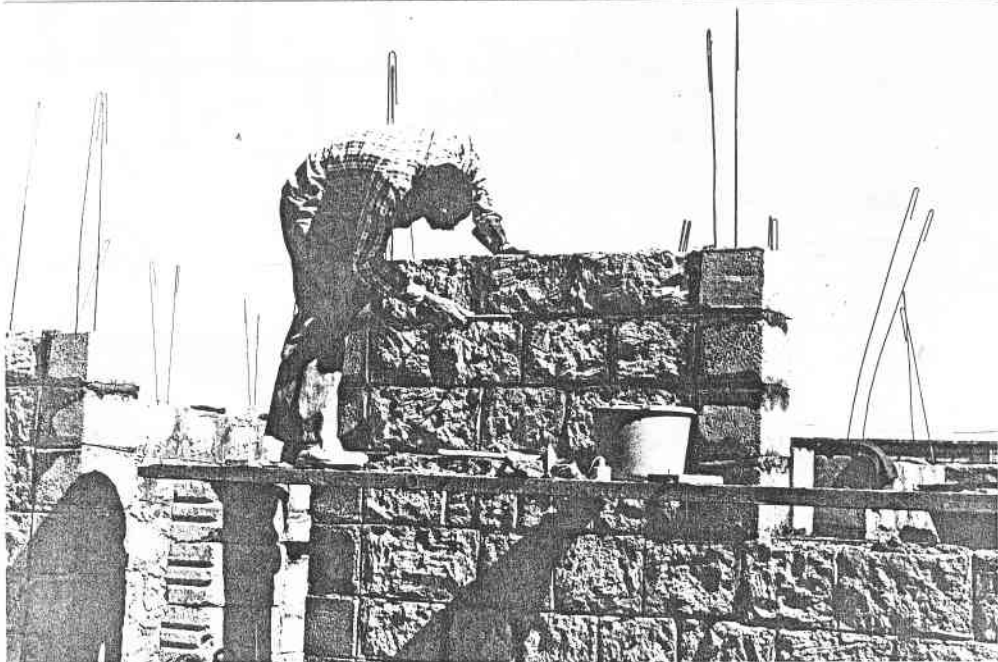
The walls were made with cut face stones although the idea of the project was to use uncoursed layers and through stones as much as possible, as was indicated on the drawings.

One of the main reasons was that at the beginning of the construction nearly all stones were cut into its typical conical way, and for a course thickness of 22cm.

A result of these cut face stones and the 30cm thick walls, is that the inside of the wall was made with many little stones and a lot of mortar.

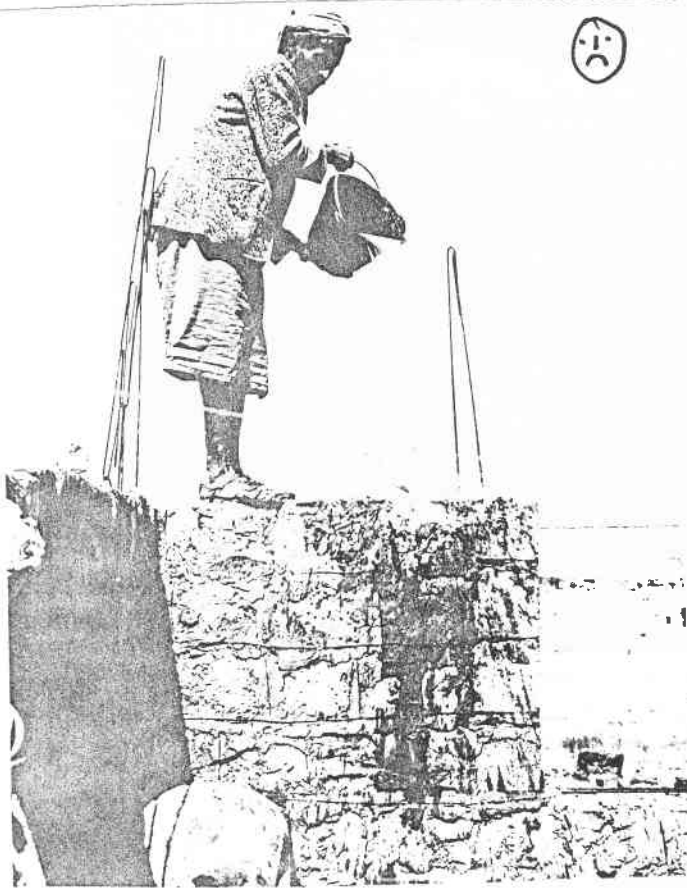
First the labourers used the hose or splashed water against the walls. More than 50% of the water (YR25/m<sup>3</sup>) came on the ground.

BAD.

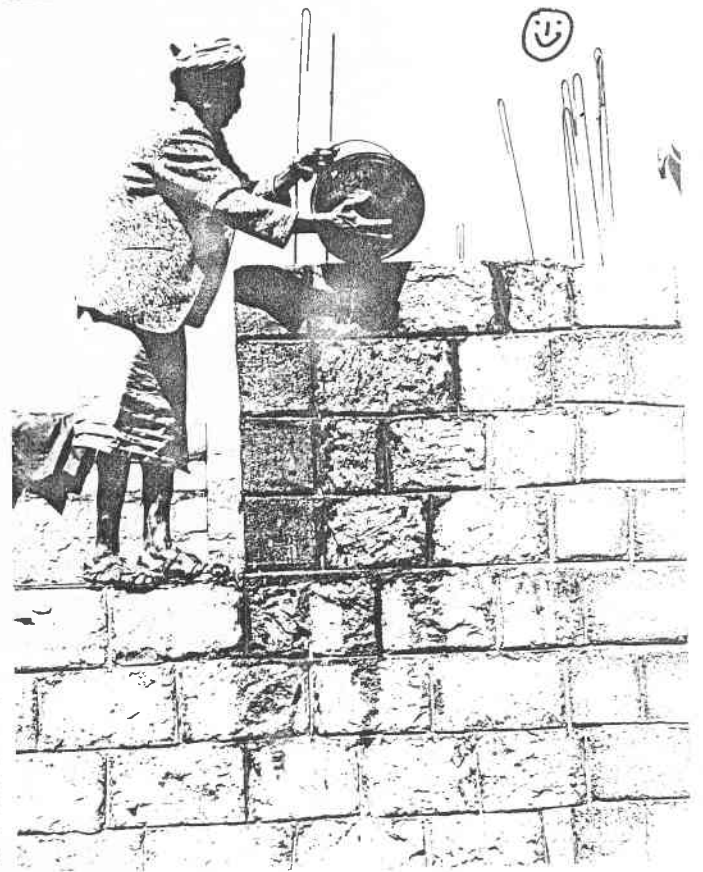
When throwing from an altitude also much water splashed away. The best method was to slowly empty the bucket on the top of the wall. Before every course the wall was wetted with the aid of a little tin.

GOOD

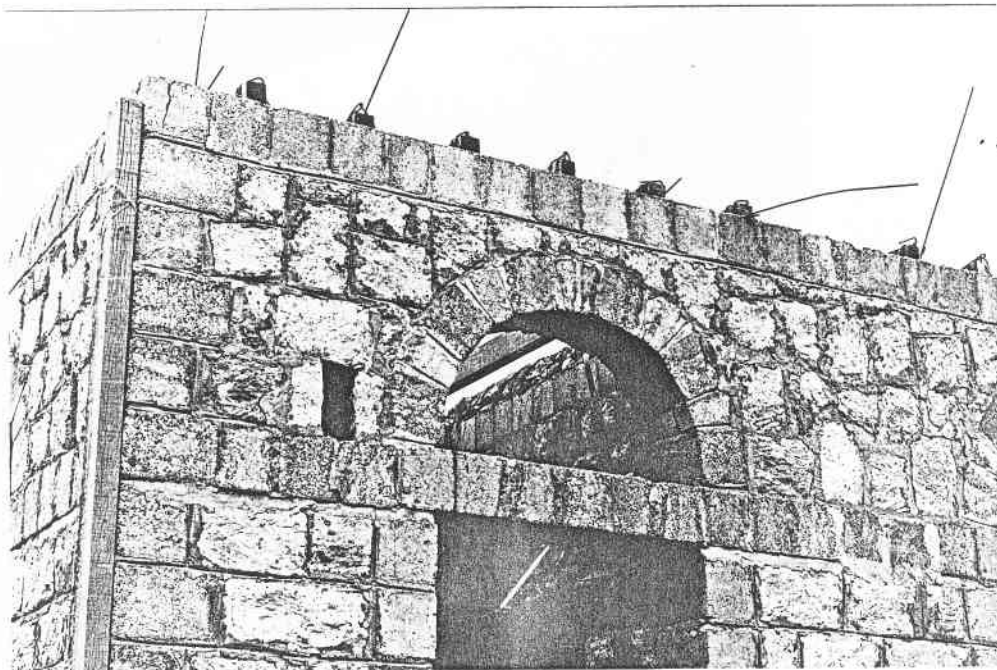
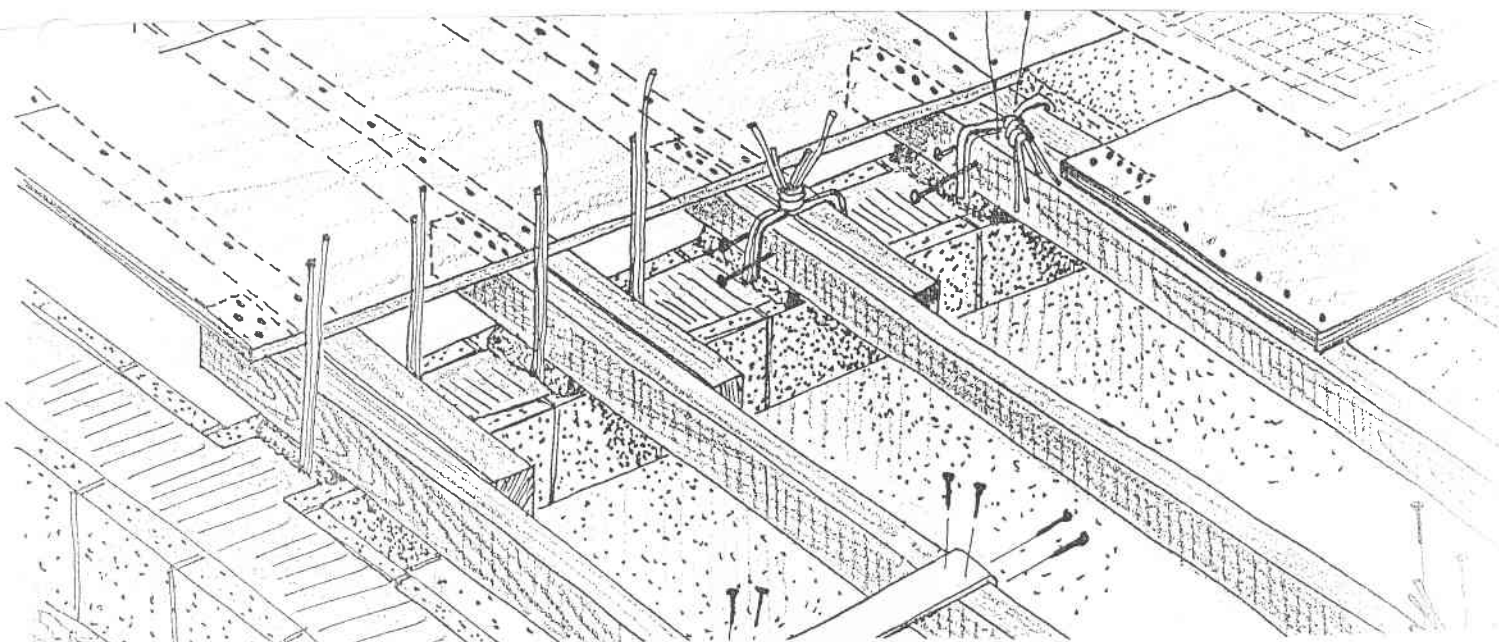
From the lower lintel tie-beam through the upper tie-beam, anchors made of 8mm steel bar were fixed around the floor joists. (6mm was designed but not available in time.) It is recommended in the modelhouse design to use two times 2 mm galvanized wires instead and fix them by twisting and nailed to the joists. The floor joists are hardwood 7 x 12 cm and all nailing was done with concrete nails. The floor joists have a whole wall thickness overlap. The joists were not cut to length, but the nearest market sizes were used.

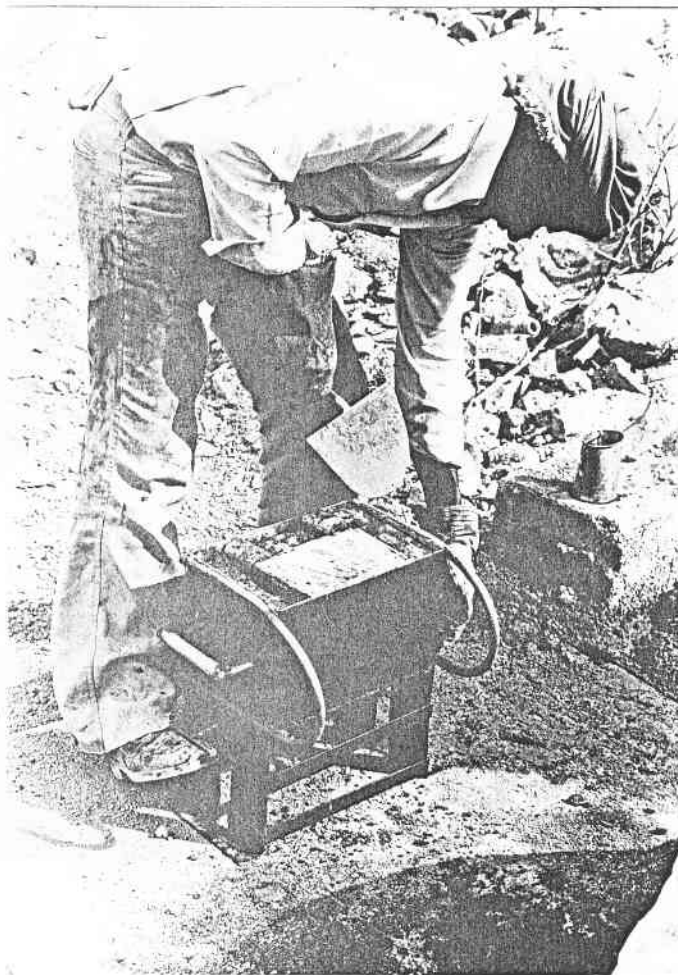
Before the mould was filled, it was cleaned.

Regularly the metal mould was moistured with water to which a little bit of diesel oil was added.

The aggregate was rather dry and several mixtures were tried out, also the cement content was gradually reduced to 1:7.

The best material showed to be a light weight volcanic coarse aggregate which is widely used for making standard cement blocks.

The mould was hand filled or with a trowel. At the same time the second person was compacting the material into the mould.

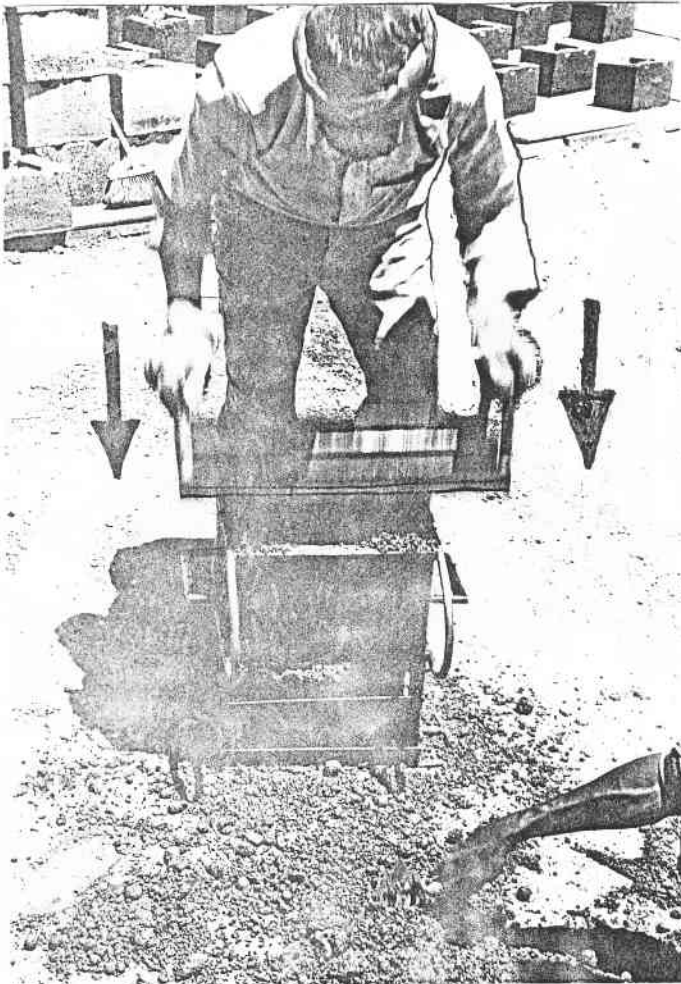
1.

The mould was filled high, with a topping up and then strongly compacted with a 6 kg heavy flat iron.

The compacting is achieved by several blows on the top of the material, thus pressing it into the mould.

The aggregate in the mould should not lose any water or get a shiny surface of the water pressed out of it.

After the first two blows, new material is added to the block by topping up all three sides of the U block and cleaning the central metal top.

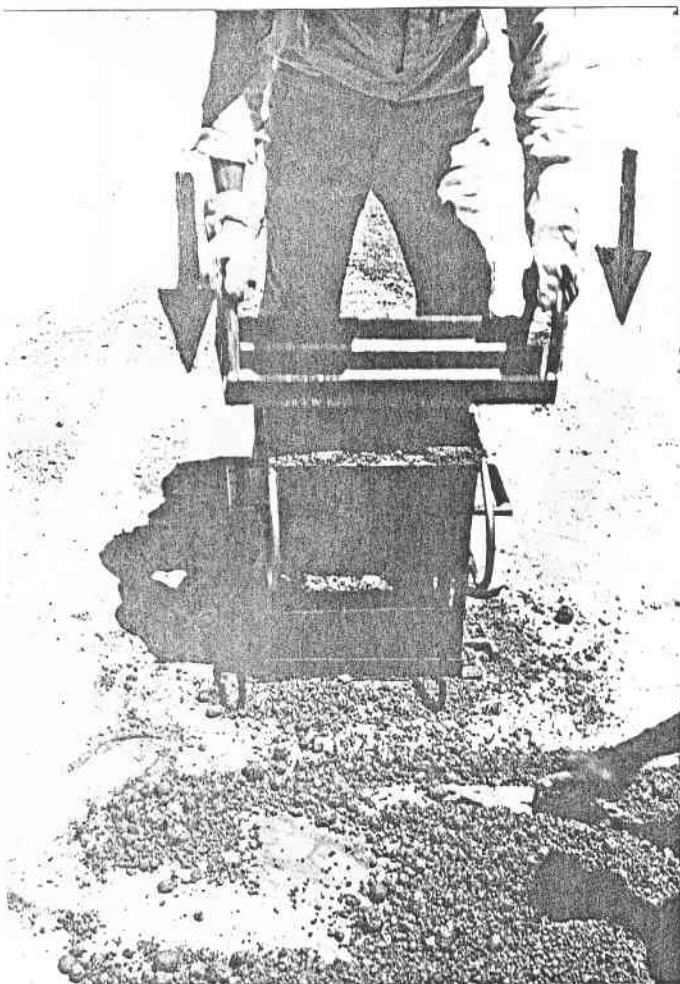
3.

After the second topping up, the material is blown again into the mould with three or four blows with the flat iron, until it does not compact any more. Attention must be given to the correct filling of the corners.

With the same flat iron the top of the mould is cleaned and the surplus aggregate material is collected for the next block.

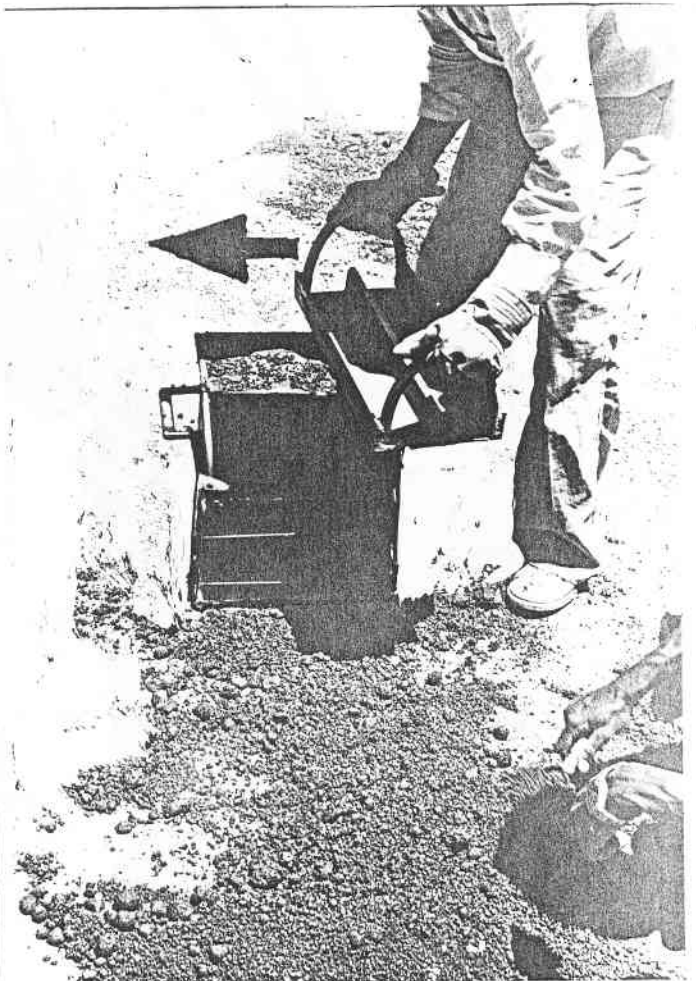
4.

Working on a flat and clean surface is important. On the site a metal sheet was used, which did not absorb any water from the mixed material.

The amount of mixed material was for about 15 blocks, so the sun would not dry out the mixture too fast.

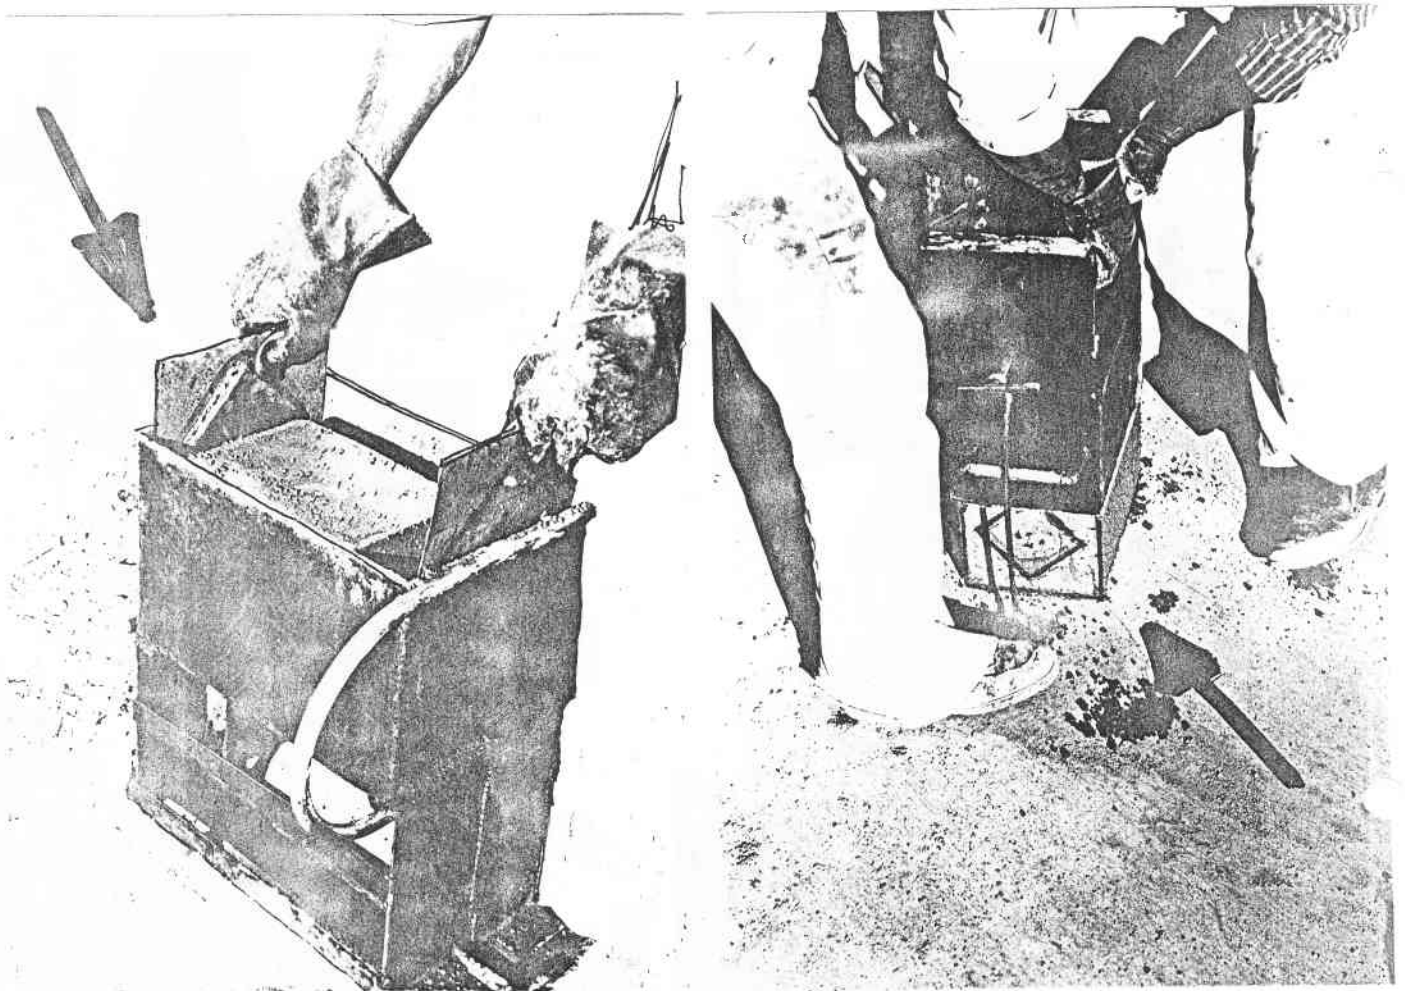
Special plates were made with geometric figures or with letters in order to make decorations in the sides of the blocks. It was found that the depth of the decorations was minimum about half a centimeter. Together with the thickness of the plate about 7 mm - 9mm, depending on the sort of figure. The sides of the U block must have therefore sufficient thickness.

For loosening the mould from the block an extra iron bar was made to hold the movable bottom down when pulling up the mould. This work was done with two persons all the time.

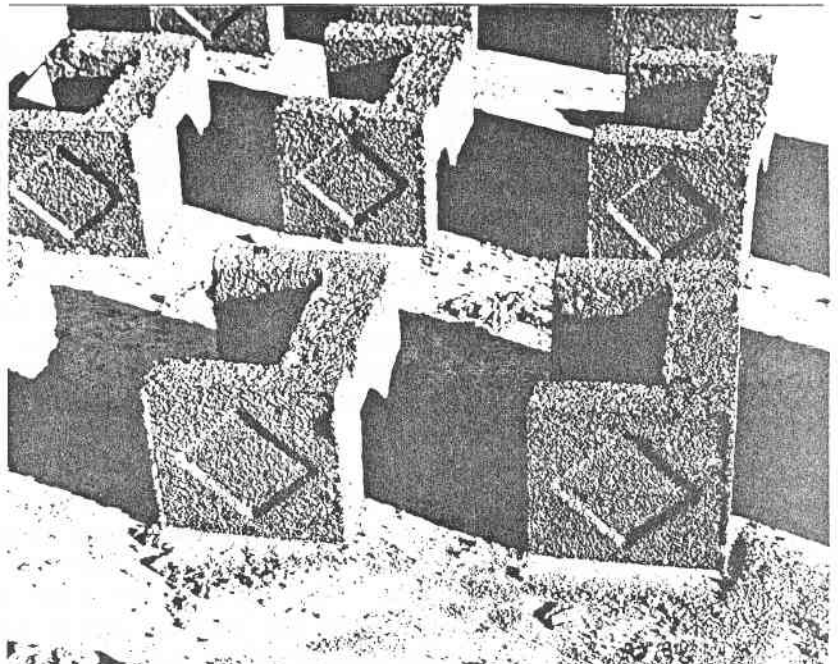
The blocks were demoulded on a platform consisting out of plywood sheets of 12mm thick, which later would be used for the roof construction of the houses.

The daily production of the two labourers was about 80 blocks, considering that the aggregate was machine mixed by themselves.

The blocks were demoulded on plywood, about 6 sheets of plywood of 120cm x 240cm were used.

The next day the blocks were piled 5 high and kept wet for at least one week, twice a day.
