Dhamar Aided Self Help  
Reconstruction Project

SUBJ: VISUAL REGISTRATION OF THE BUILDING OF THE STAFF HOUSES  
PLANNING ACTIVITY NO 50.

Diskette: 650.NYN.ORG  
DHAMAR AIDED SELF HELP RECONSTRUCTION PROJECT  
FILE: 3.4160.62.03  
DATE: 29 JULY 1984  
SUBJ: VISUAL REGISTRATION OF THE BUILDING OF THE STAFF HOUSES  
PLANNING ACTIVITY NO 50. (addition to house construction 1)

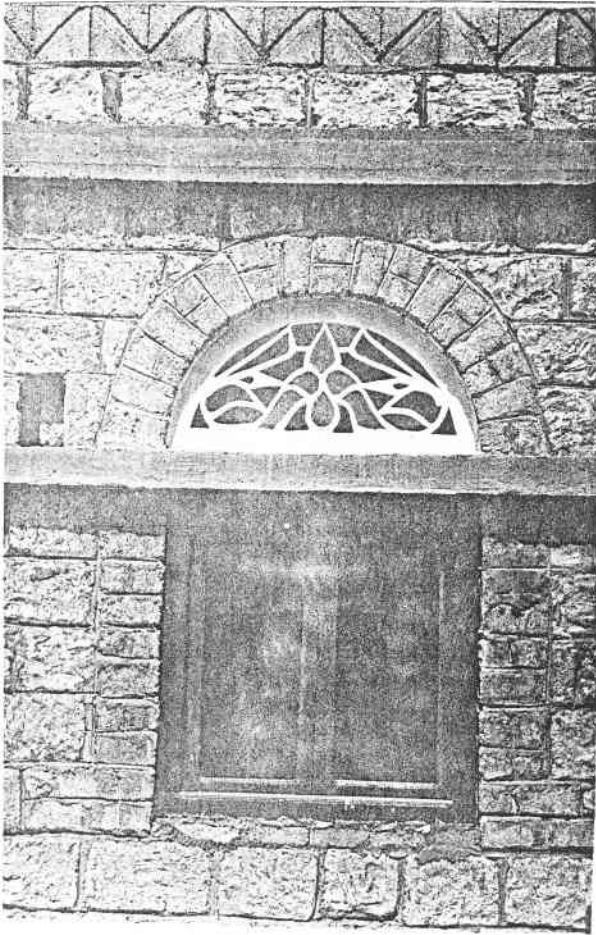
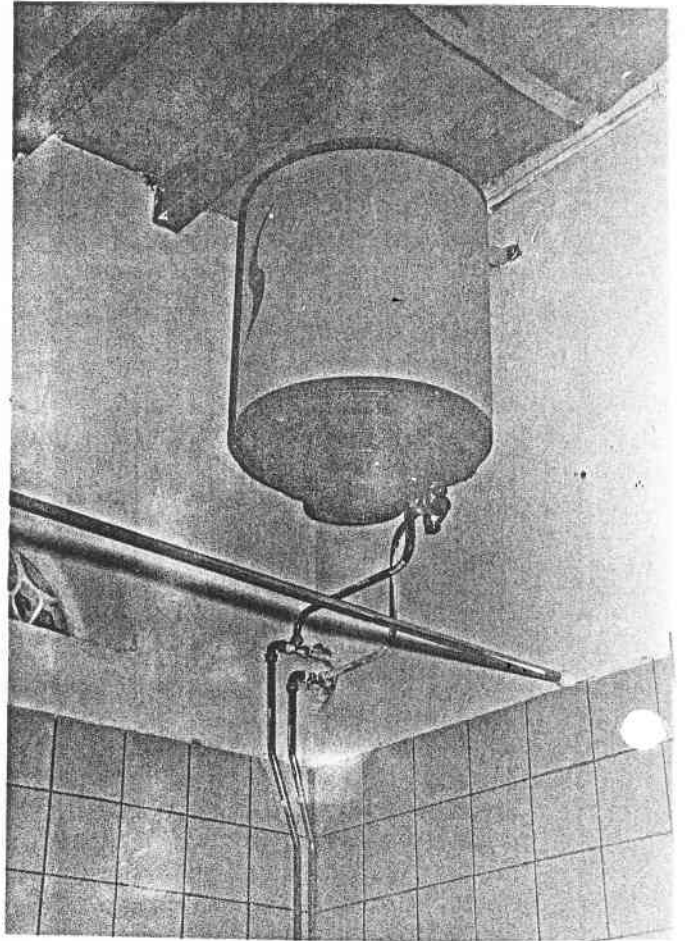
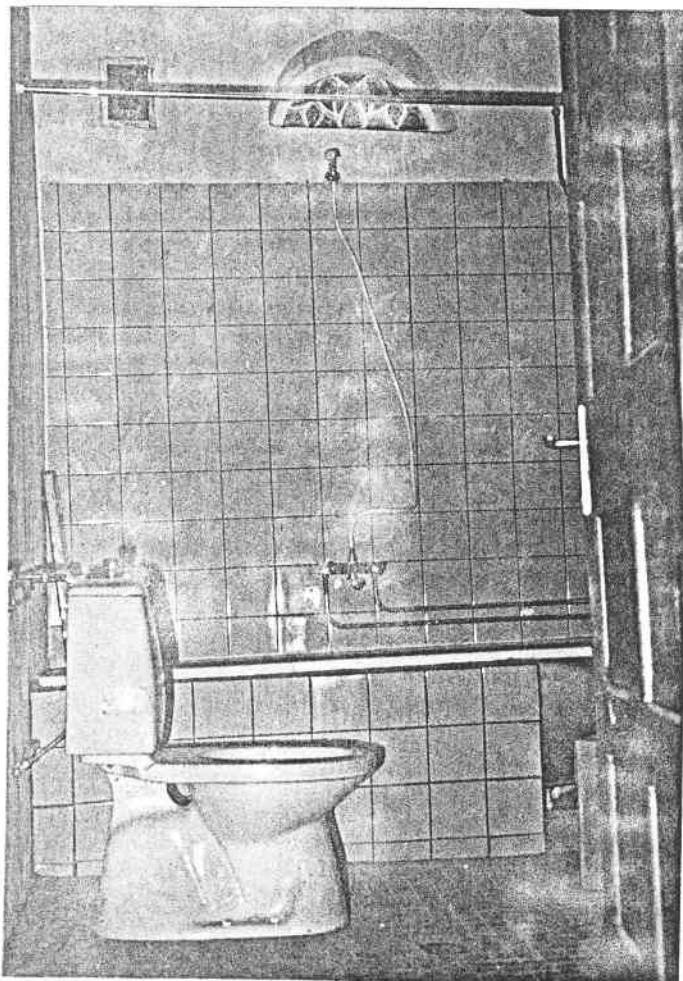
The following pictures show some of the interior finishings of the staff houses.
