Aga Khan Planning and Building Services, Pakistan  
Building and Construction Improvement Programme – BACIP

# **FIELD VISIT HABITAT RISK MANAGEMENT PROGRAMME (HRMP)**

**NOVEMBER 2008**

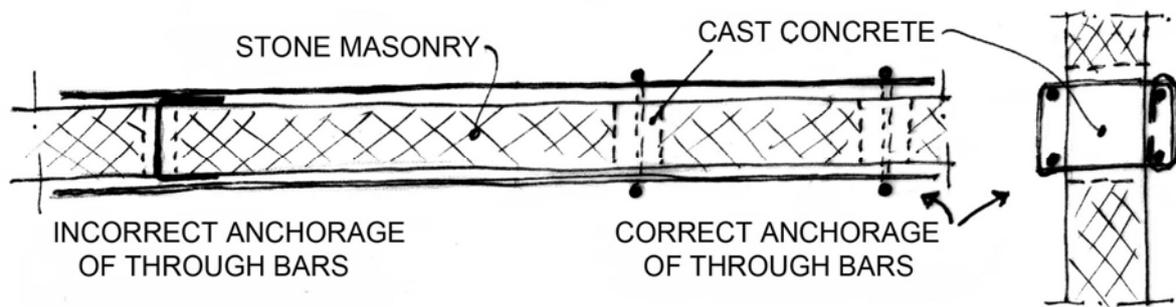
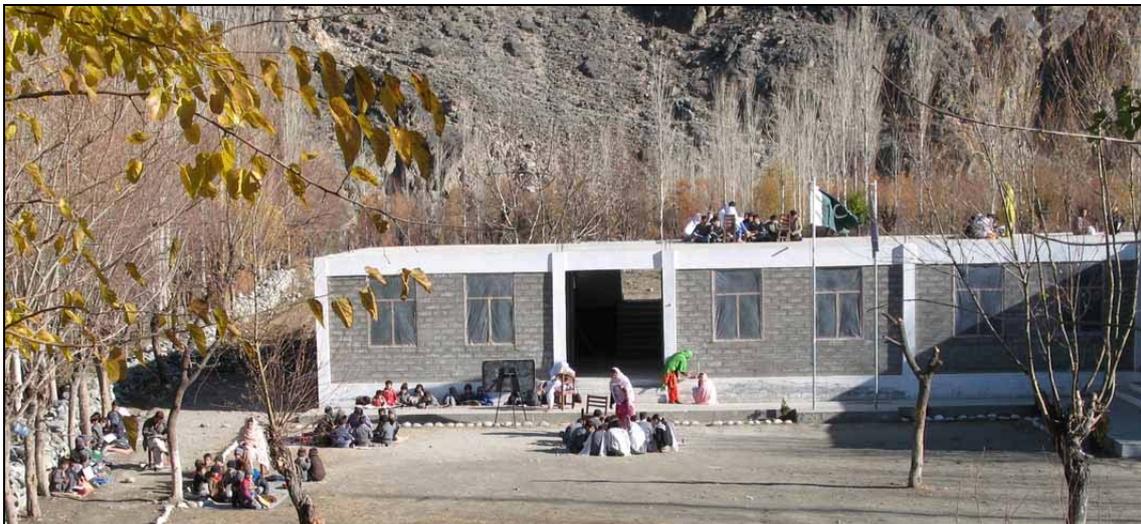
As could be observed from the reinforcement details of one of the exterior columns, the lintel strip reinforcement is going inside the vertical reinforcement while these should be fitted around the vertical reinforcements.

In addition, in the opinion of the mission, the number of through-the-wall anchoring is insufficient and the single bar with hook inadequate.

The connection between the inside ring beam and outside ring beam is based on only one single bar passing through the wall instead of going back again, making a full loop. The number of through connections between the inner and outer ring beam is rather low. The vertical bars are from the window framing, placed correctly<sup>3</sup>.

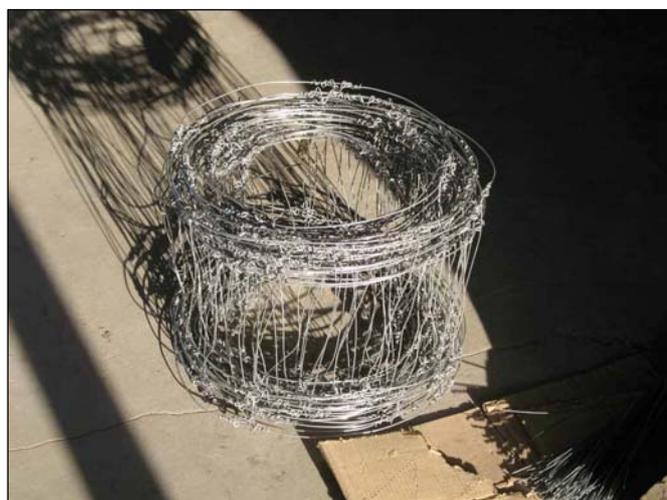
Here a massive foundation reinforcement inside and outside was realised and the roof lightened. A single bar between the foundation and roof will be applied in the four inside corners of the main room and plastered. These bars won't hold up anything if the wall fails. The detailing of this corner solution is surprising because in the school design there were through connections in the corners, creating double and anchored columns; why then not in a weaker adobe house?

View of the massive foundation ring beam of the small one-floor-only adobe house

The BACIP-GWR has been especially designed for traditional stone and adobe walls that are not masoned with strong cement mortar. The rolls of wire mesh are available in the region.

Adobe walls should be entirely reconstructed with the GWR instead of applying external “reinforcement”.
