Repair of Brick Houses

after the 2010-2015
Groningen
Earthquakes

By Ing. Sjoerd Nienhuys March 2023

Part 0 = Introduction

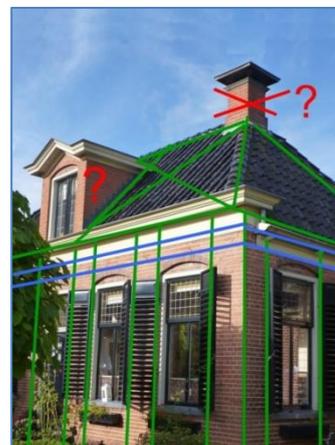
Picture right. The same building on the other side, with the possible internal reinforcement options listed.

- ✓ The chimney needs to be replaced by a lightweight copy.
 - ✓ Internal support of the dormer window is needed.
 - ✓ Stiffening of the roof construction is needed.
 - ✓ Continued lintel reinforcement above all windows around the building.
 - ✓ Making the attic floor diaphragm and with that connecting all the walls.
 - ✓ Vertical reinforcement of window piers with steel or with a timber skeleton frame inside or make windows from very strong construction glass panels.
 - ✓ Insulate all the outside walls on the inside after strengthening.
- Or
- ✓ Place the entire building on Bas- insulation and also thermally insulate the entire building from the inside.
